# New England Rail Trail

## Trail Development Plans

Armidale – Black Mountain  
Ben Lomond – Glen Innes

## FINAL REPORT

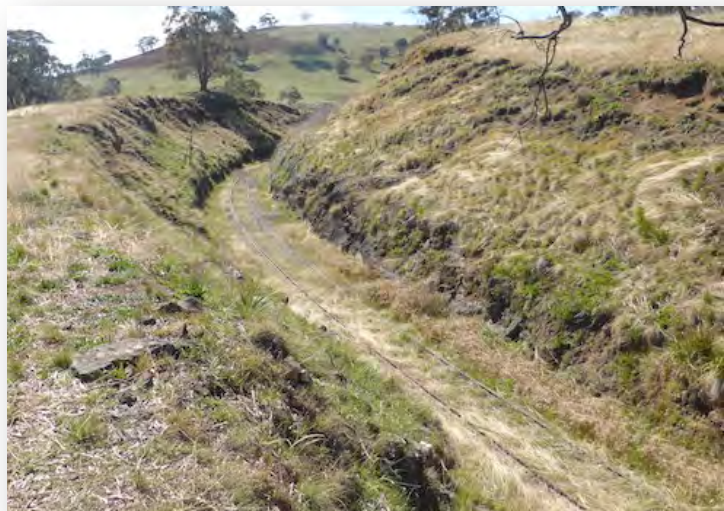
*The old drains of the many cuttings along the proposed rail trail will require attention to ensure they still perform the task of clearing water from the cuttings.*

Numerous culverts inspected during fieldwork were completely or partially block, thereby inhibiting the free flow of stormwater under and away from the railway embankment. Regular cleaning of blocked culverts is essential to avoid serious soil and water degradation problems.

Those sections of the railway formation which do have blocked culverts or dysfunctional drains should be attended to in the trail construction process, as allowing water to stand on the proposed trail surface or run down even a gentle slope is to invite surface damage followed by costly repairs.

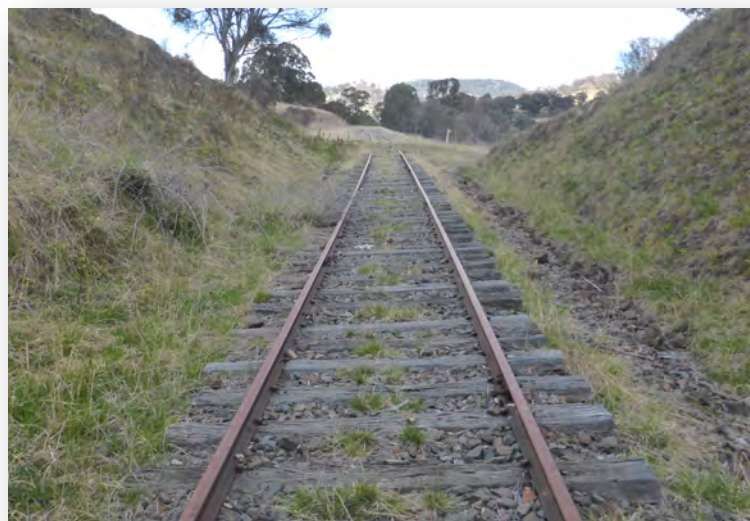
*A considerable amount of ballast still remains along the proposed trail route and must be removed in the trail construction process.*

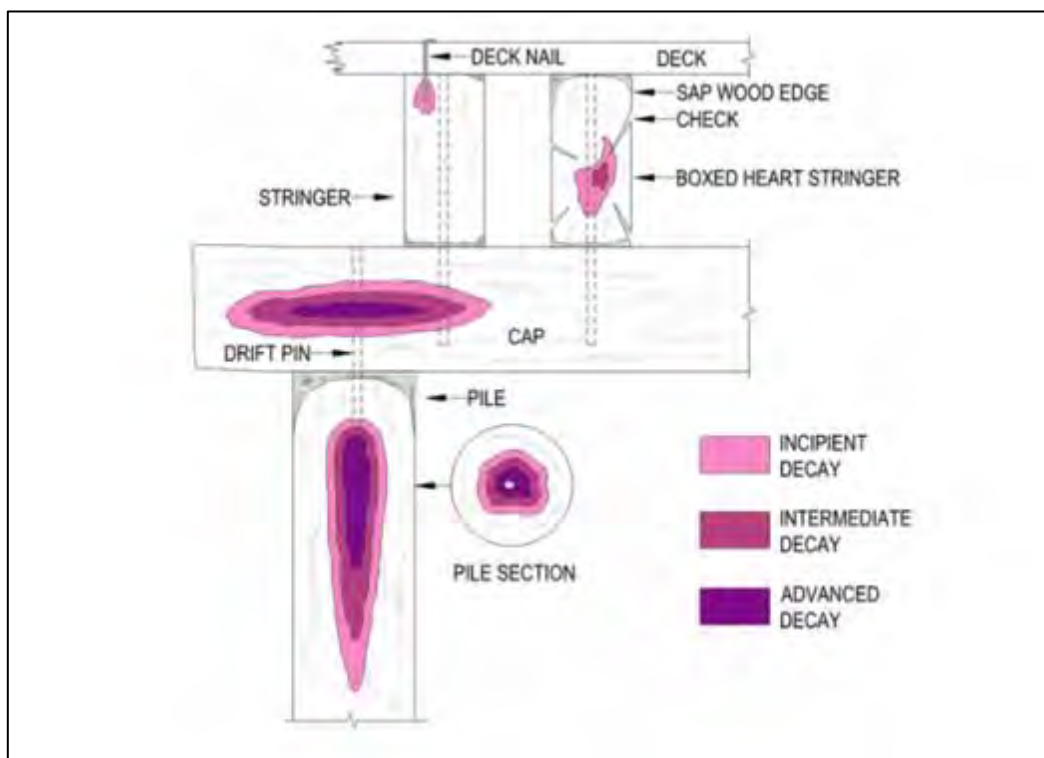
**Figure 3-2:** Shows the level of decay that occurs in timber due to the use of vertical fasteners. Vertical fasteners increase the rate of decay in timber as they allow moisture to travel down the fastener into the heartwood of the headstock (cap), girders (stringers), corbels and piles, therefore increasing the moisture content in the middle of these elements. The heartwood of a log element is less capable of breathing and expelling moisture than the sapwood that surrounds it, so vertical connectors funnel the moisture directly into the heartwood accelerating decay. Once the moisture content exceeds 22%, timber consuming fungi are activated and the decay process begins.

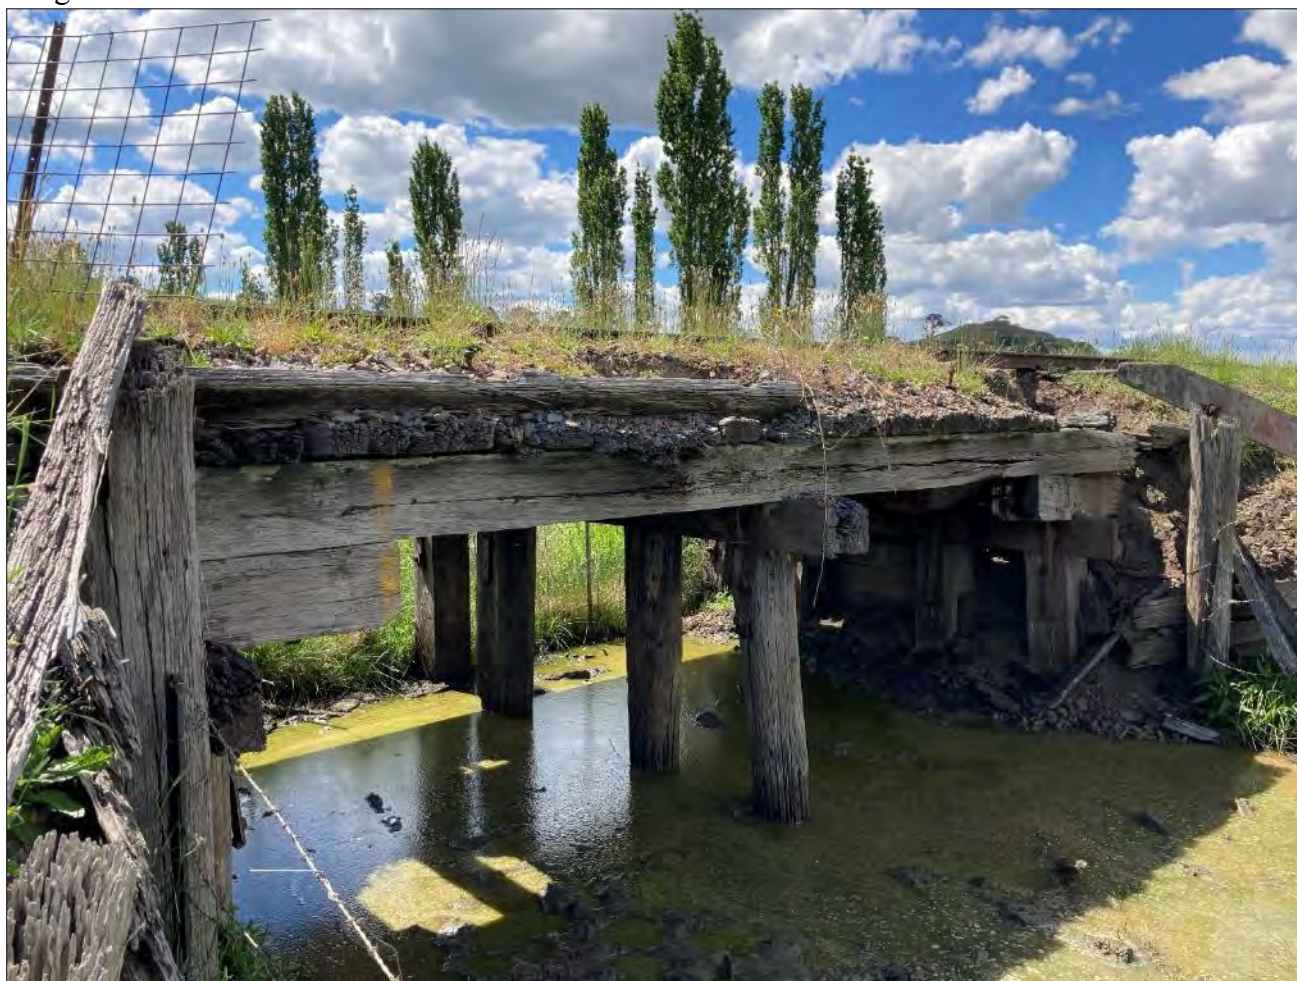
**Figure 4-1: View of Old Ben Lomond Rd Bridge from Abutment 1. The timber bridge is 2 spans long and approximately 8 metres long. At the time of inspection, the water was not flowing (boggy ‘spring’) and had a maximum depth of 0.5m. The wingwalls and backwalls have significantly deteriorated and no longer retain any of the approach fill material. Also note there is a fence located/attached on the left side of the bridge. Also note the horizontal crack on Girder 4 which is a key sign of internal decay and section loss causing the beam to fail under the deadweight of the bridge alone.**

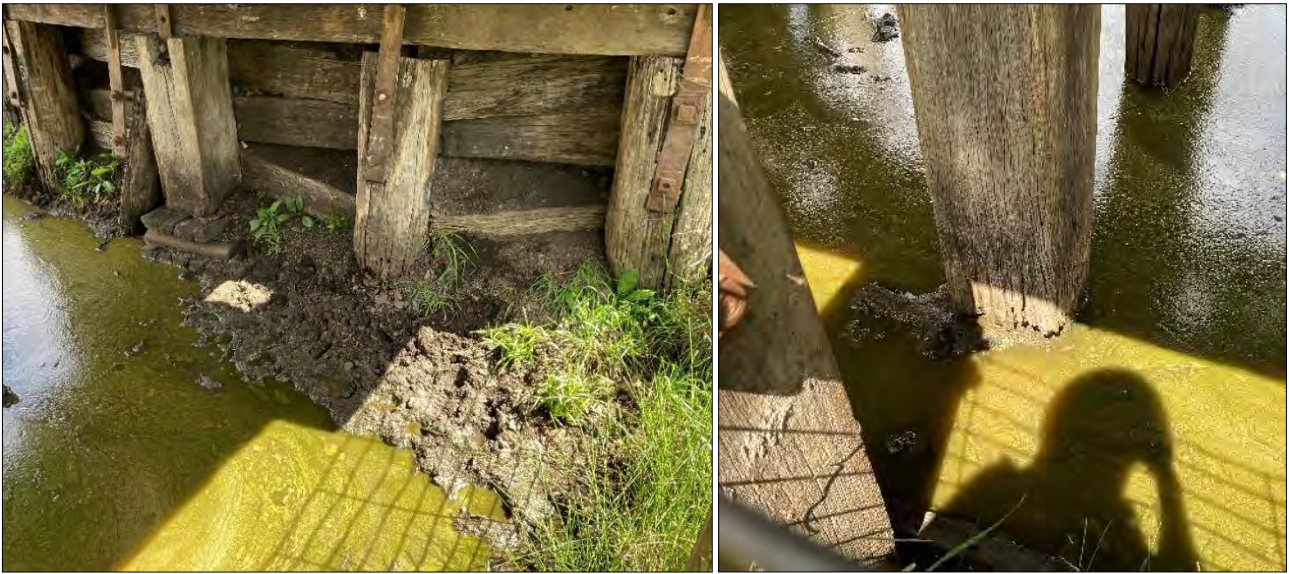
**Figure 4-2: View of the timber abutments and pile. The bents comprise of 4 piles with significant deteriorated found and evident with timber packers placed under some piles (Pile 3 in the left-hand image above). Overall the timber bents were found to be in very poor condition with a complete re-build required. Breast walls were burst and pile to cap connection was lost.**

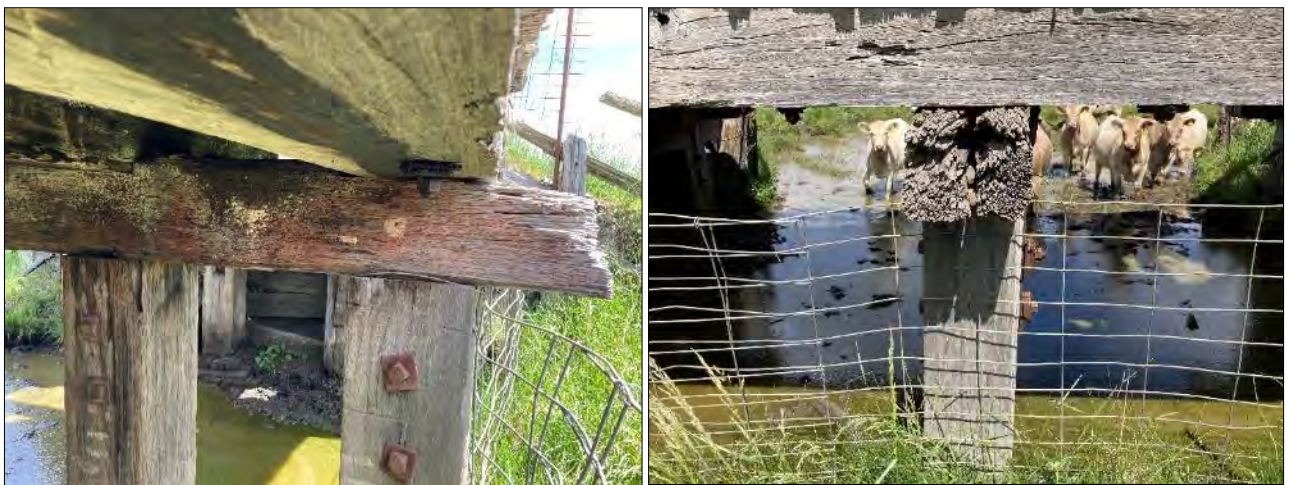
**Figure 4-3: Most elements have started to undergo significant decay with Bent 1 cap visibly decayed above. Large amounts of fungi growth (white spots) are evident on most elements and is seen in the left-hand image above. Once the moisture content in the timber elements reaches 22%, decay causing fungi are activated and the decay process begins.**

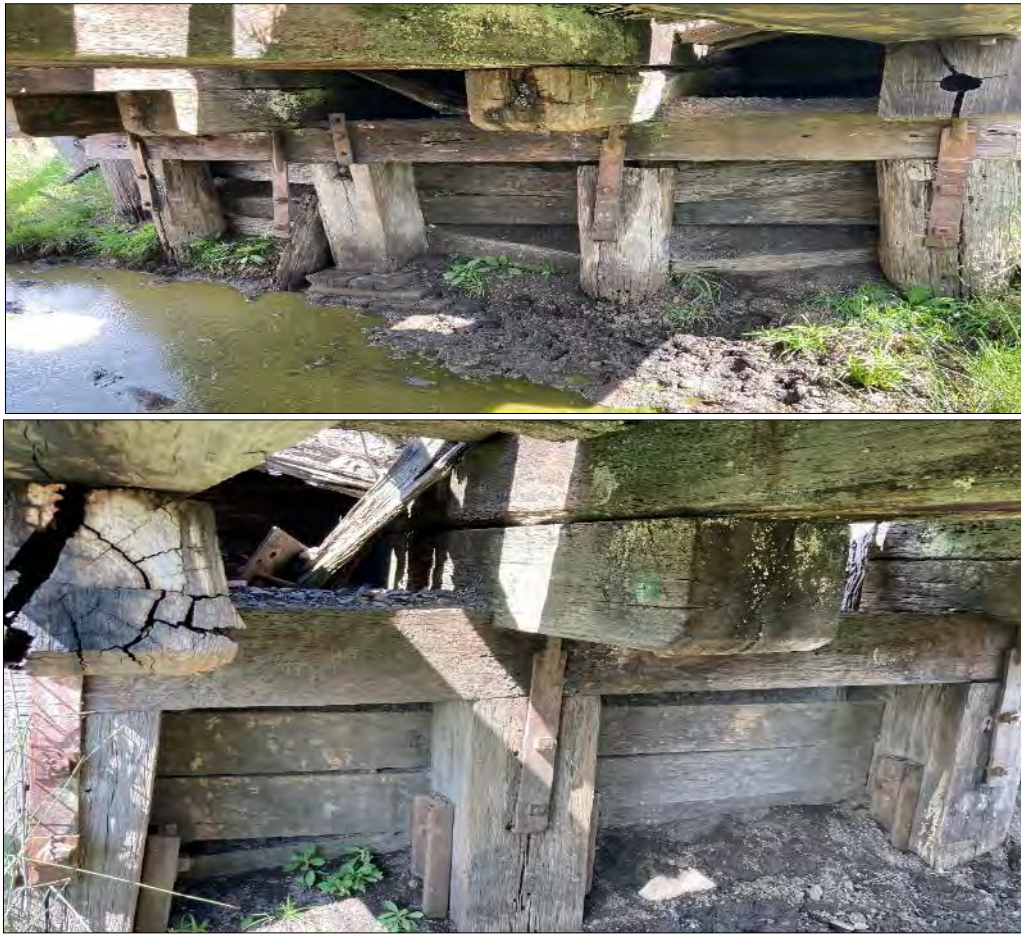
**Figure 4-4: More evidence of decay present as there is large fungi growth on most elements. Brief NDT testing was completed using non-destructive methods, such as EPHOD® Stress Wave Technology. Refer to Appendix A for more information of this type of testing method. Readings above 2000-3000 $\mu$ s was recorded for the time taken for the compression wave to travel across the section of the member tested. This was recorded on most elements. Deterioration of this magnitude means that the Modulus of Elasticity/Modulus of Rupture in various stress directions (wood is anisotropic with different strength properties in different directions) has deteriorated to an extent that the element can no longer support its own dead weight. Readings between 1000 $\mu$ s and 2200 $\mu$ s indicate that the member cannot carry its own dead weight in these regions. Readings in excess of 2200 $\mu$ s can signify a cavity while a reading above 3300 $\mu$ s indicates the element can no longer support its own dead load and is at risk of failing at any point. Refer to Section 4.3 below for a full list of recommended repair options for refurbishment to a pedestrian/cycle bridge.**

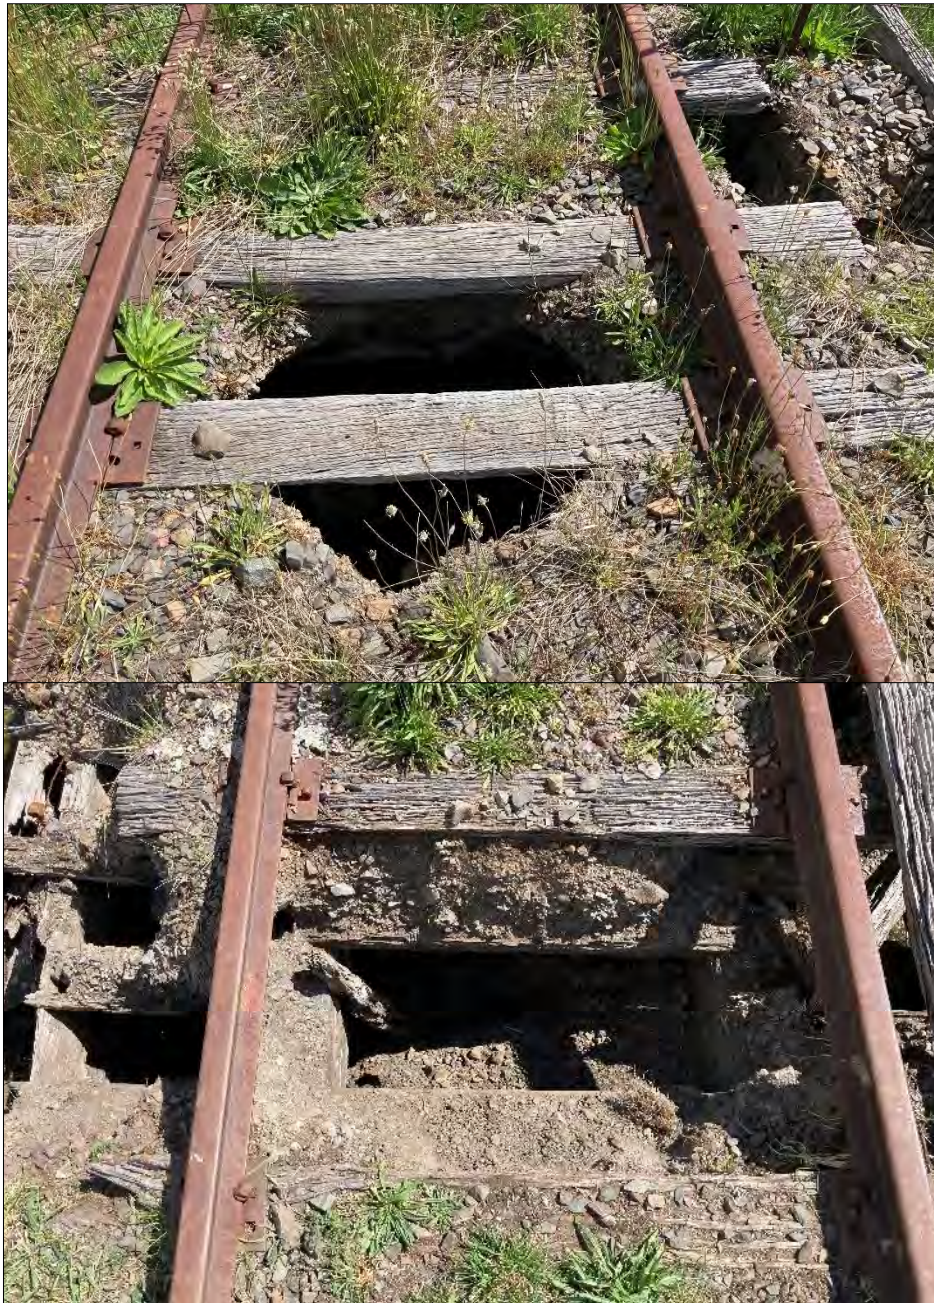
**Figure 4-5: The timber transoms (rail ties) were found to be in a poor condition with fouled ballast and lost ballast. If the bridge was to be repurposed for pedestrian and cycle use the timber transoms, railway line and rock ballast would be required to be removed. The existing timber edge rail that contains the ballast can left in place to act as a kerb/kick rail in the repurposed bridge. To meet the current standards and Australian codes; vertical balustrade panels and a 1.4m high cycle rail will need to be installed. The current width of the bridge from inside of kerb to inside of kerb is approximately 3.0 metres which will result in a code compliant width for pedestrian bridges. As many of the deck planks are ‘falling’ out a new deck would be required for this bridge.**

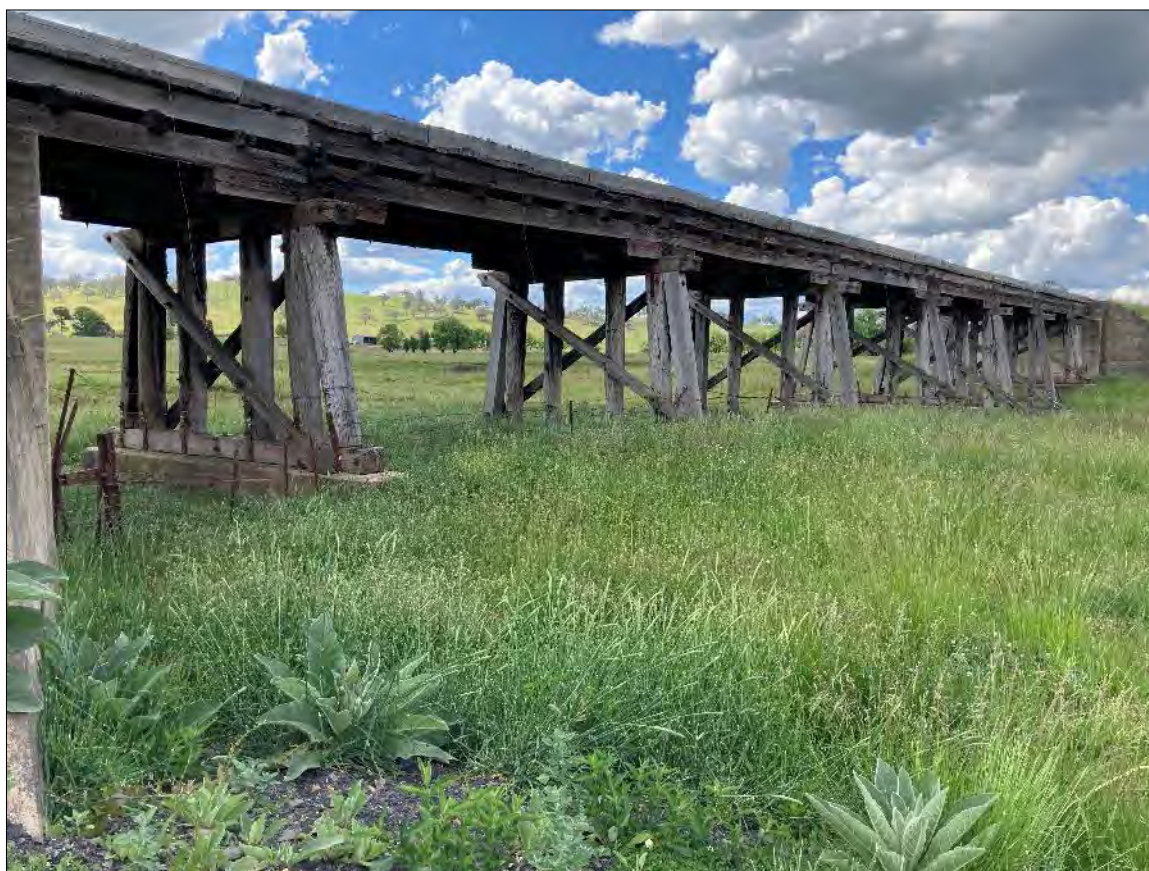
**Figure 5-1: View of Manrowan Creek Bridge from the Abutment 1 end of the structure. The timber girder under bridge has 8 spans in total with an overall length of 56m. This type of design was quite common for the longer spans that transverse over the larger creeks along the New England Railway line. At the time of inspection there no water flowing in Manrowan Creek, only a pool of water approximately 1m deep at spans 5 & 6.**

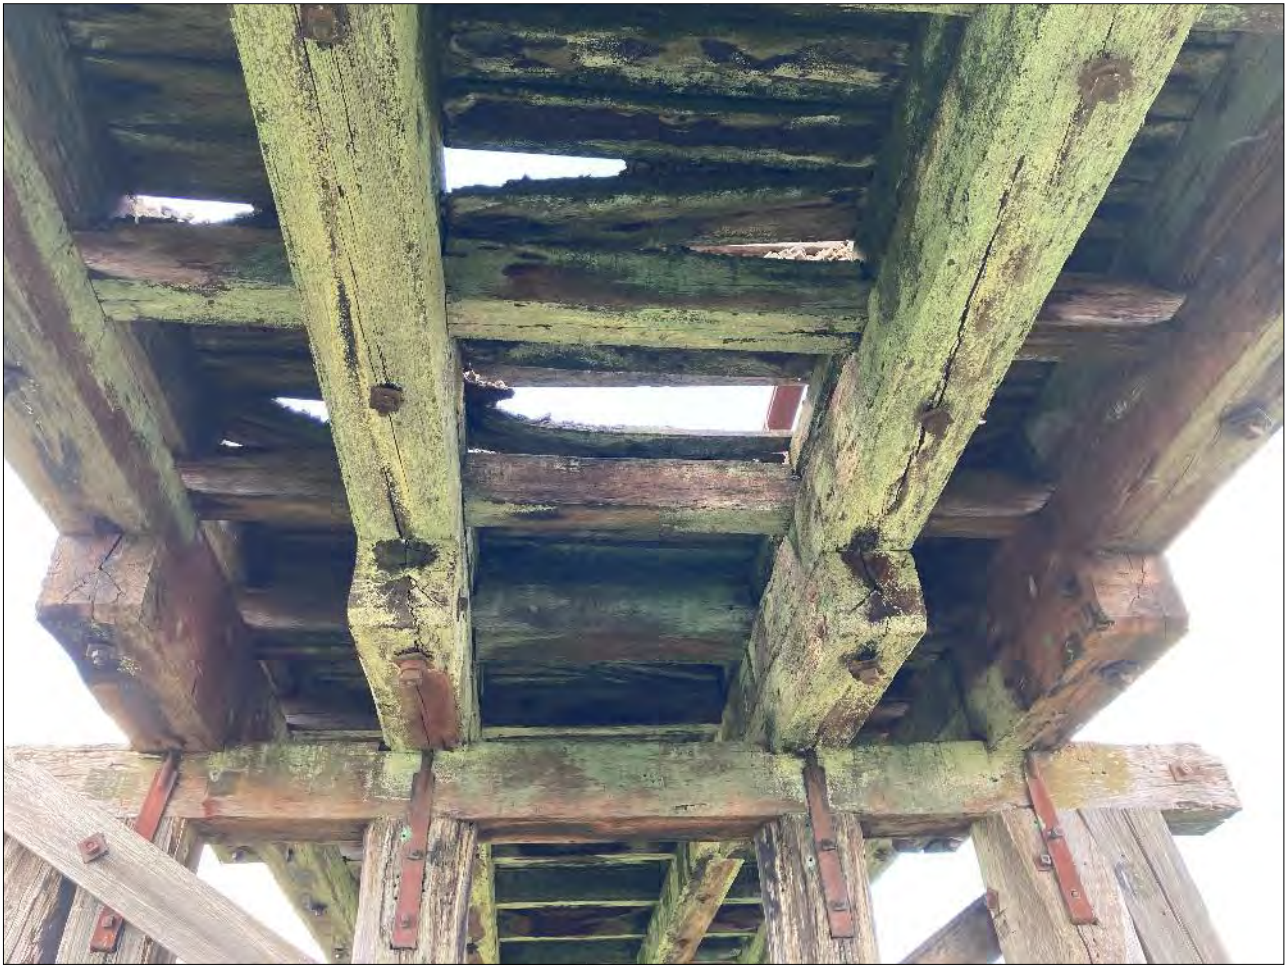
**Figure 5-2: A view of the underneath section of the bridge. It can be seen that the deck has collapsed in sections along the bridge. These planks will require replacement before the bridge can be reopened for pedestrian and cycle use. The superstructure comprises of 4 solid sawn girder lines per span with the 2 girders per a girder line (8 girders per span in total). The double stacked girders are separated by traverse beams that contribute to the load sharing ability of the superstructure. Generally the transverse beams were in poor condition and the girders are in poor-very poor condition. One of the girders has undergone significant deterioration with large splits visible from the underneath as well as being covered fully in decay fungi growth. The girders and corbels are connected with large vertical through bolts. Vertical fasteners increase the rate of decay in timber as they allow moisture to travel down the fastener into the heartwood of the girders and corbels where evaporation is more difficult, therefore increasing the moisture content in the middle of these elements over longer periods of time. The heartwood of a large dimensional element is less capable of breathing and expelling moisture than the sapwood that surrounds it, so vertical connectors funnel the moisture directly into the heartwood accelerating decay. Once the moisture content exceeds 22%, timber consuming fungi are activated and the decay process begins. Refer to Figure 3-2 for a detailed description of how and where the decay occurs due to these vertical bolts.**

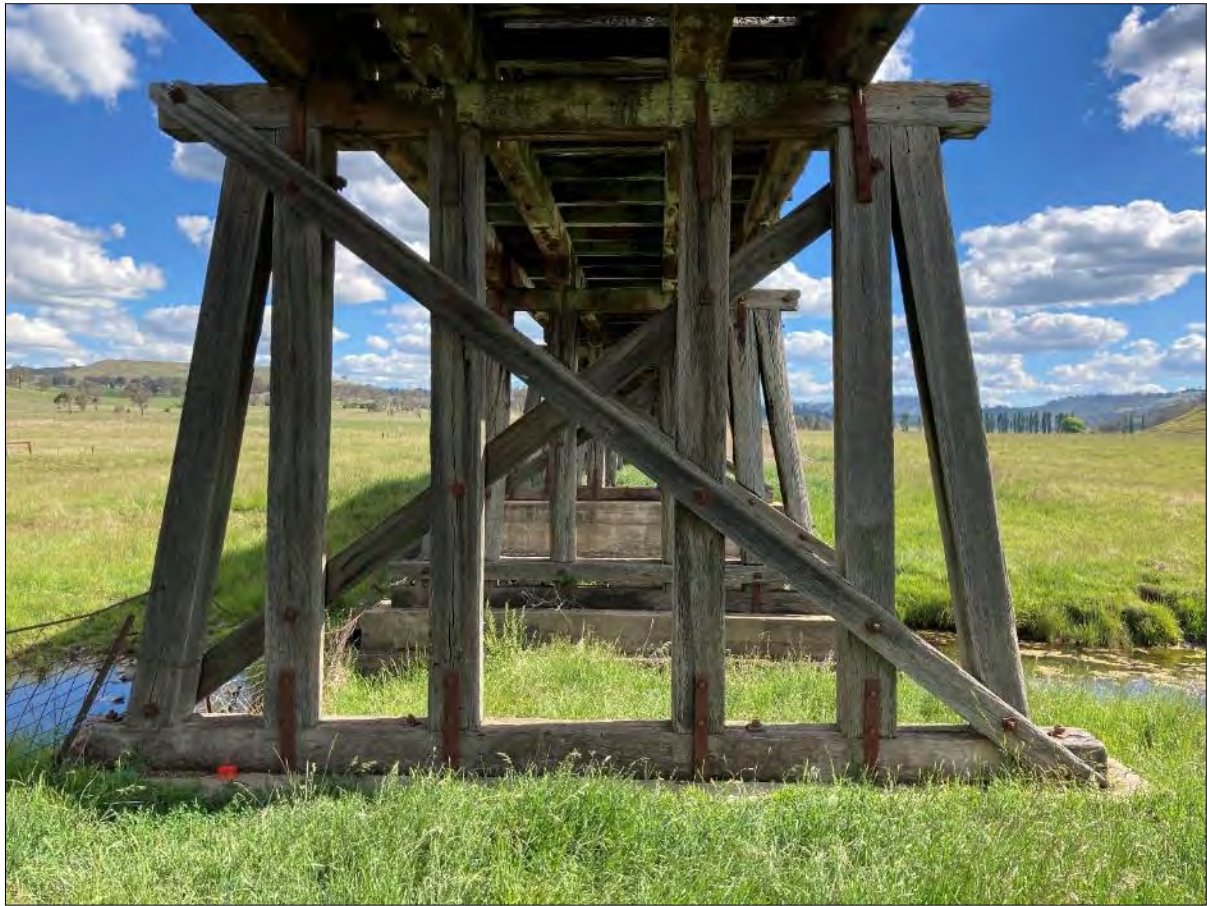
**Figure 5-3: View of the typical timber pile bent configuration. The bent comprises of 6 square (or round) dimensional post bearing directly on a timber bottom cap which is vertically connected to the concrete footing. The bent is also supported by cross bracing that provides adequate support for the 2.5-4m long posts. Overall the timber bents were found to be in a poor condition with the timber bottom caps being in the worst condition. This is as per expected due to the timber bearing directly on the concrete footing which typically has a high moisture content. Over time the timber post undergoes capillary action and draws up the moisture like a ‘straw’. Once the moisture content in the timber elements reaches 22%, decay causing fungi are activated and the decay process begins. This timber bottom cap has partially ‘protected’ the timber posts which are in relatively poor condition, however the timber cap wales will cost a significant amount to be replaced or repaired in-situ.**

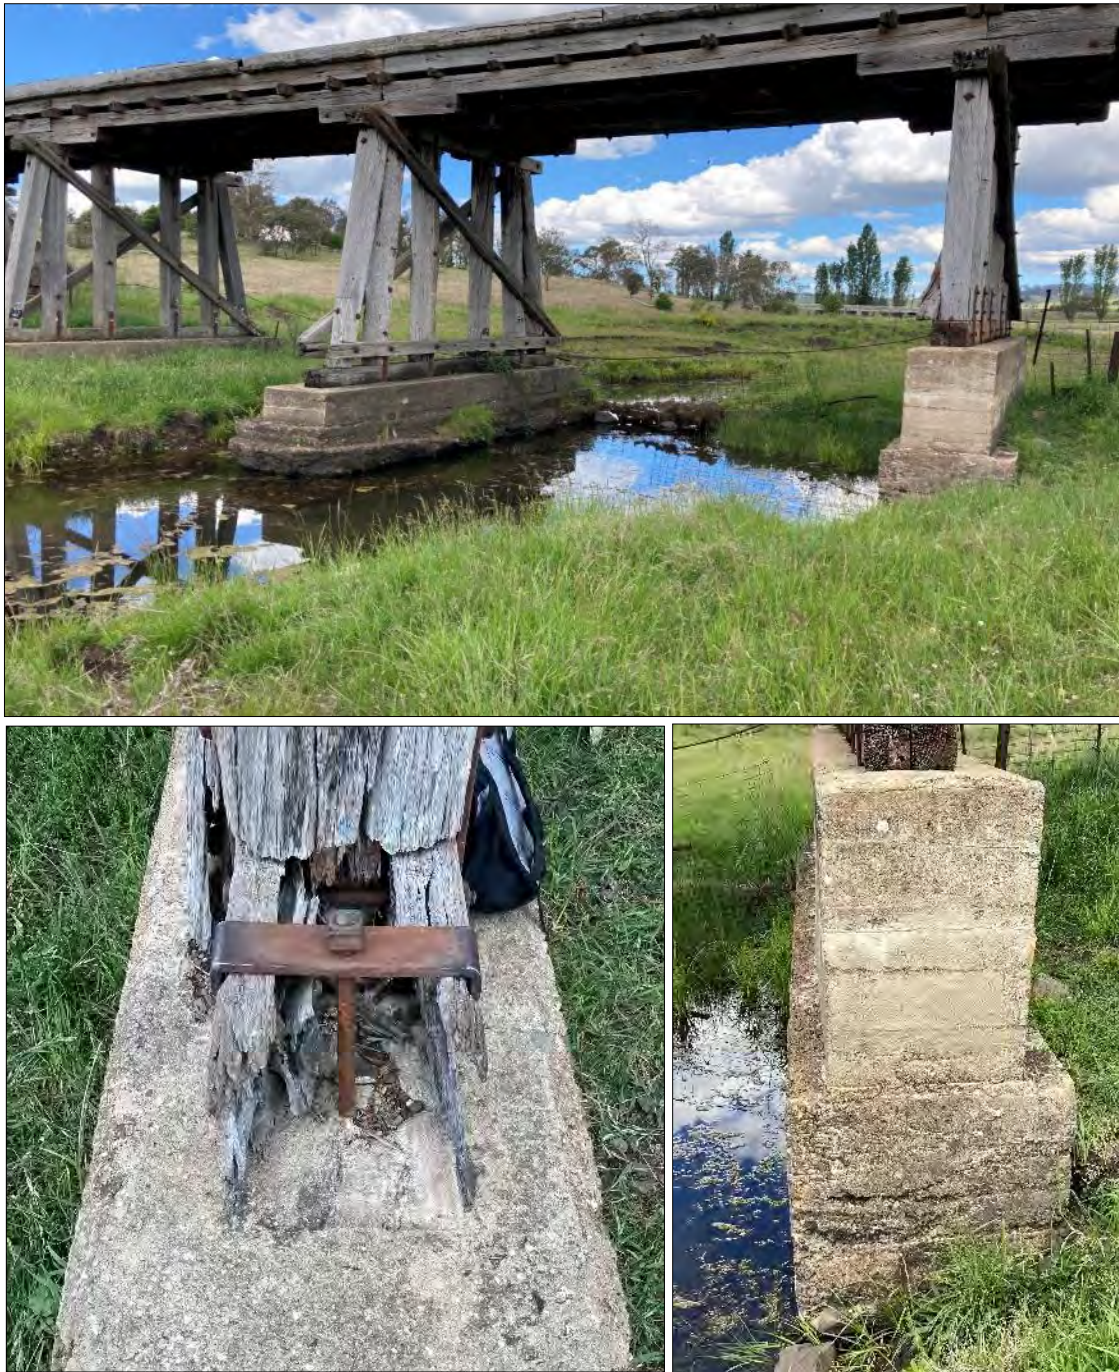
**Figure 5-4: View of Spans 5 & 6 where the creek mainly flows. A close-up view of the decayed bottom cap that is vertically connected to and directly bearing on the concrete footing. Also the 2 concrete footing on either side of the main stream flow (Span 5) have signs of deterioration and scour. Scour protection (rip rap) is recommended to be installed.**

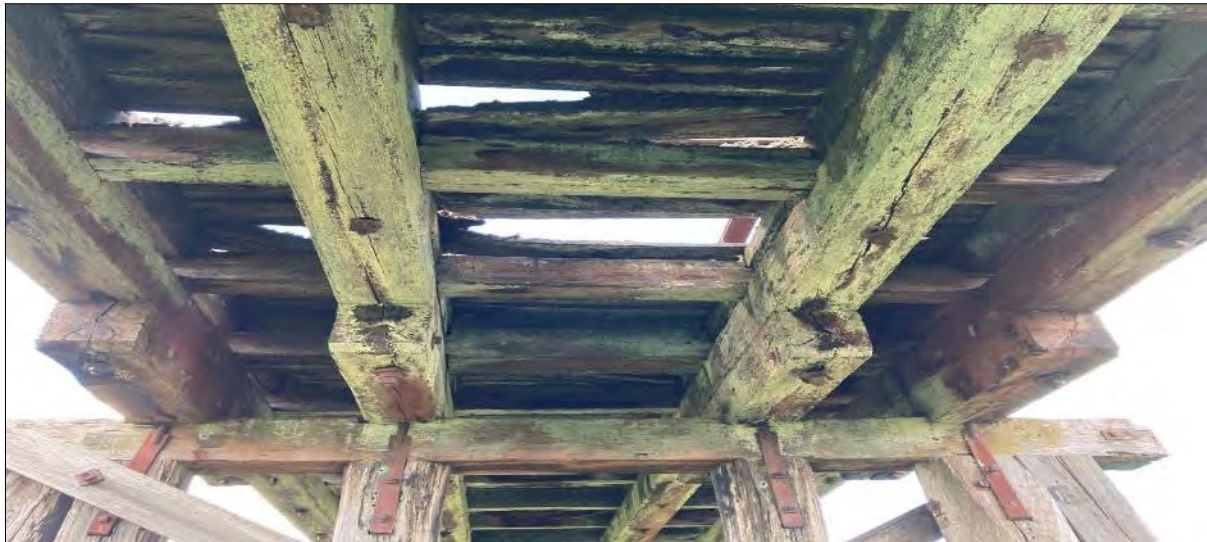
**Figure 5-5:** A view of a section of the deck that has collapsed. These planks will require replacement before the bridge can be reopened for pedestrian and cycle use. The ballast rock will also be required to be removed to accommodate pedestrian and cycle traffic. Large amounts of decay fungi growth evident which indicates large amount of deterioration present.

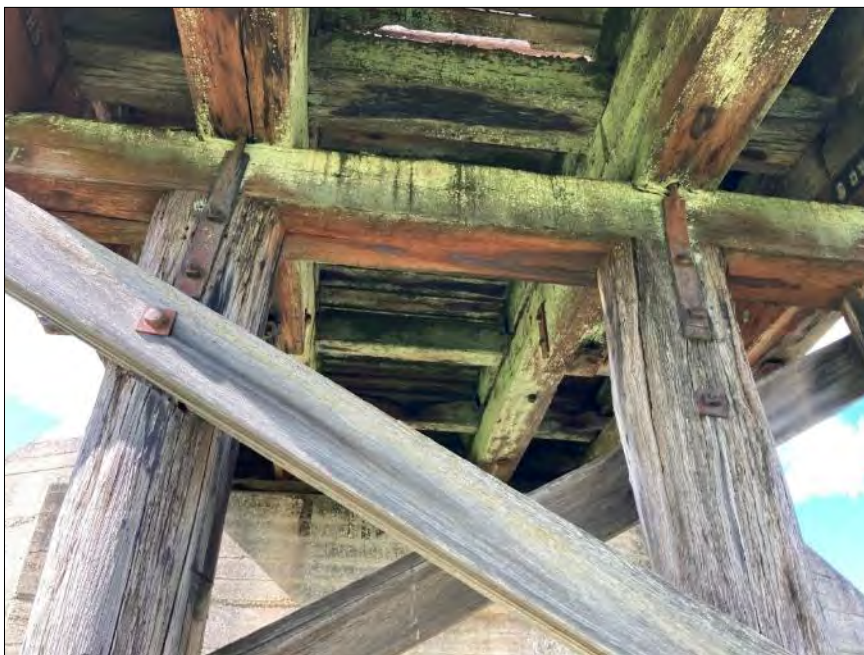
**Figure 5-6:** Close-up view of the approach span. The members are connected with a vertical through bolt. Vertical fasteners increase the rate of decay in timber as they allow moisture to travel down the fastener into the heartwood of the girders and corbels where evaporation is more difficult, therefore increasing the moisture content in the middle of these elements over longer periods of time. The heartwood of a large dimensional element is less capable of breathing and expelling moisture than the sapwood that surrounds it, so vertical connectors funnel the moisture directly into the heartwood accelerating decay. Once the moisture content exceeds 22%, timber consuming fungi are activated and the decay process begins.

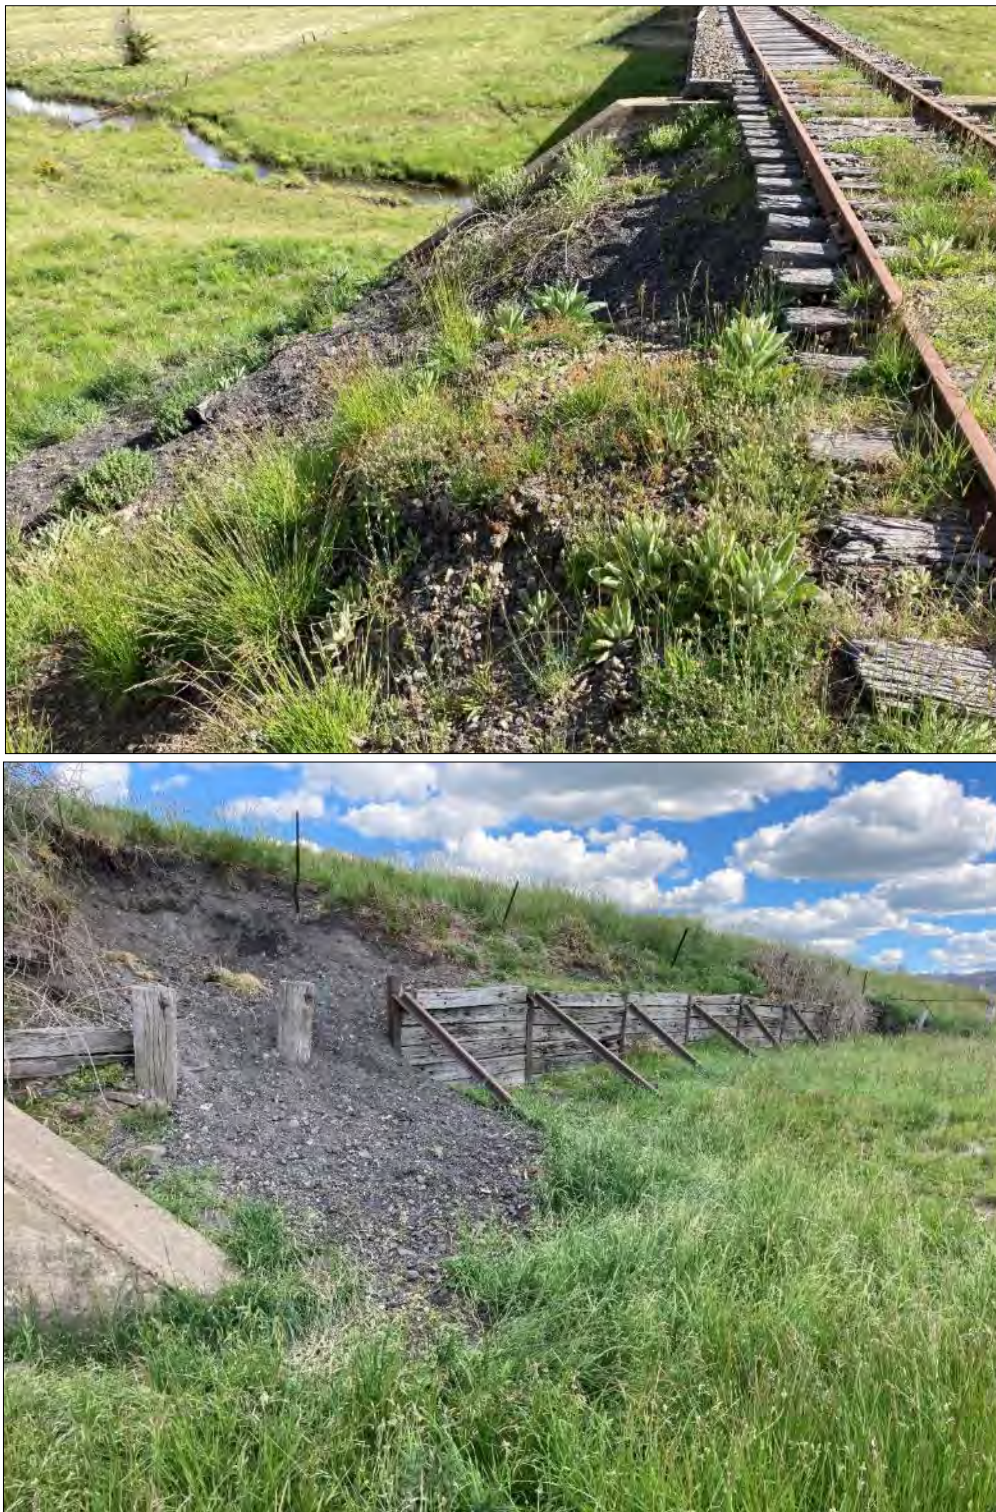
**Figure 5-7: View of the typical approach configuration. The formation of the line has been significantly raised to pass over the creek which has resulted in steep unstable slopes on each side/end. The approach retaining wall is in very poor condition and requires repair to achieve a safe and stable approach formation.**

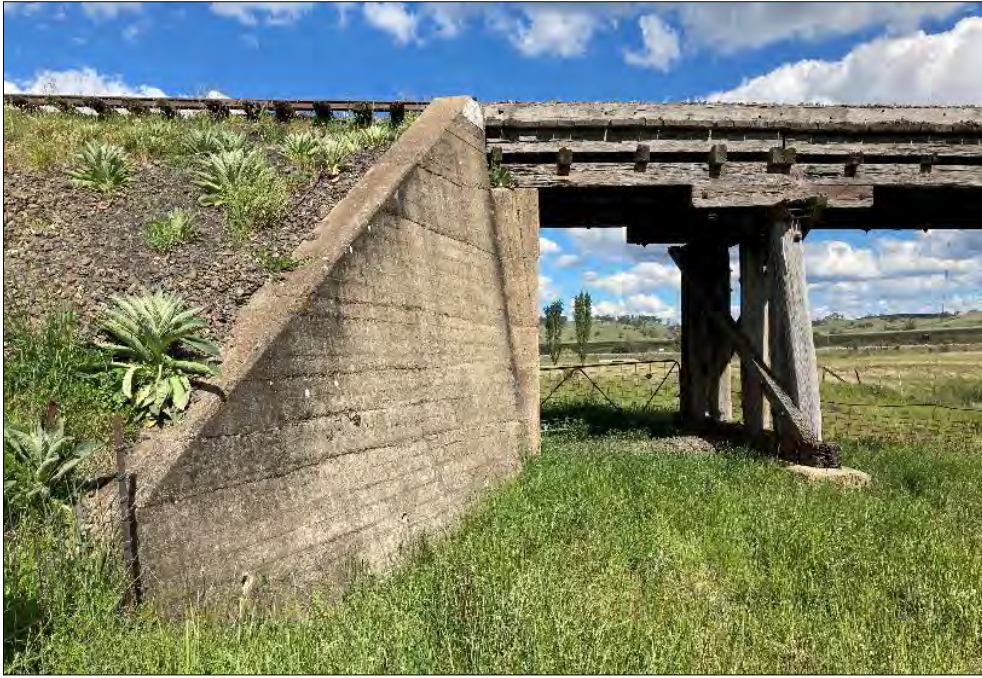
**Figure 5-8: View of Abutment 1 which is the typical board-formed, poured place, concrete wing and breast wall configuration. The concrete mass block/seat is in fair condition with the wingwalls intentionally angled back towards the approaches to help overcome the large forces from the approach fill.**

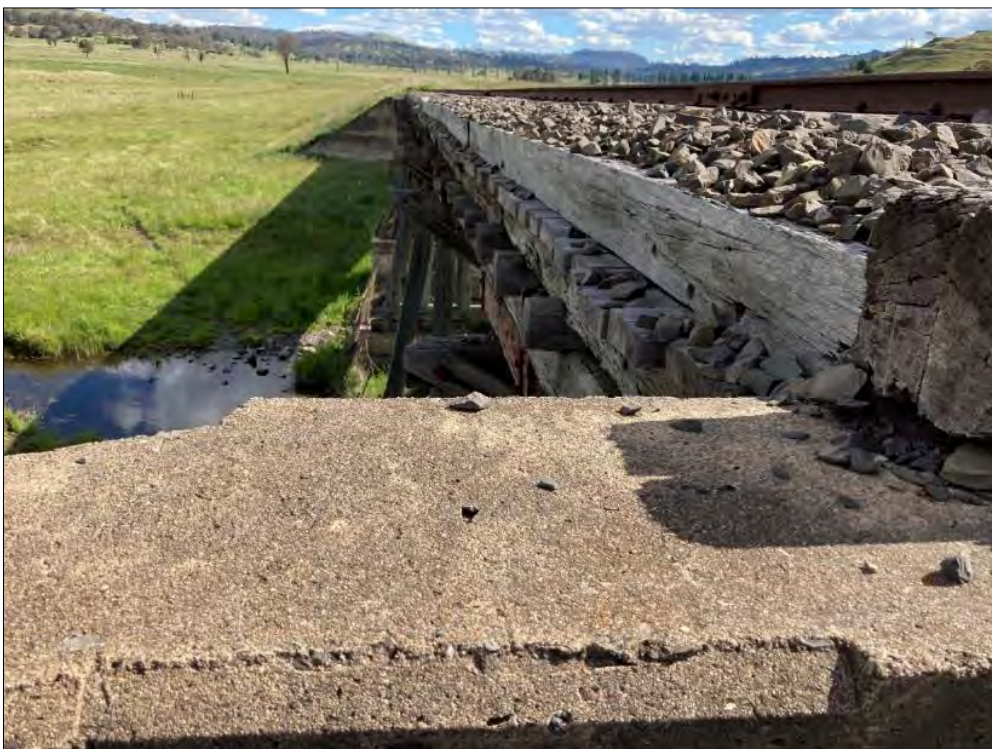
**Figure 5-9: View of Side 2 (Right-hand side) of the bridge from Abutment 2. The bridge maintains a fairly straight alignment while the decay of the bents/girders are visible to the uneven ‘drops’ along the length of the bridge. The ballast tray remains intact with most of the ballast.**

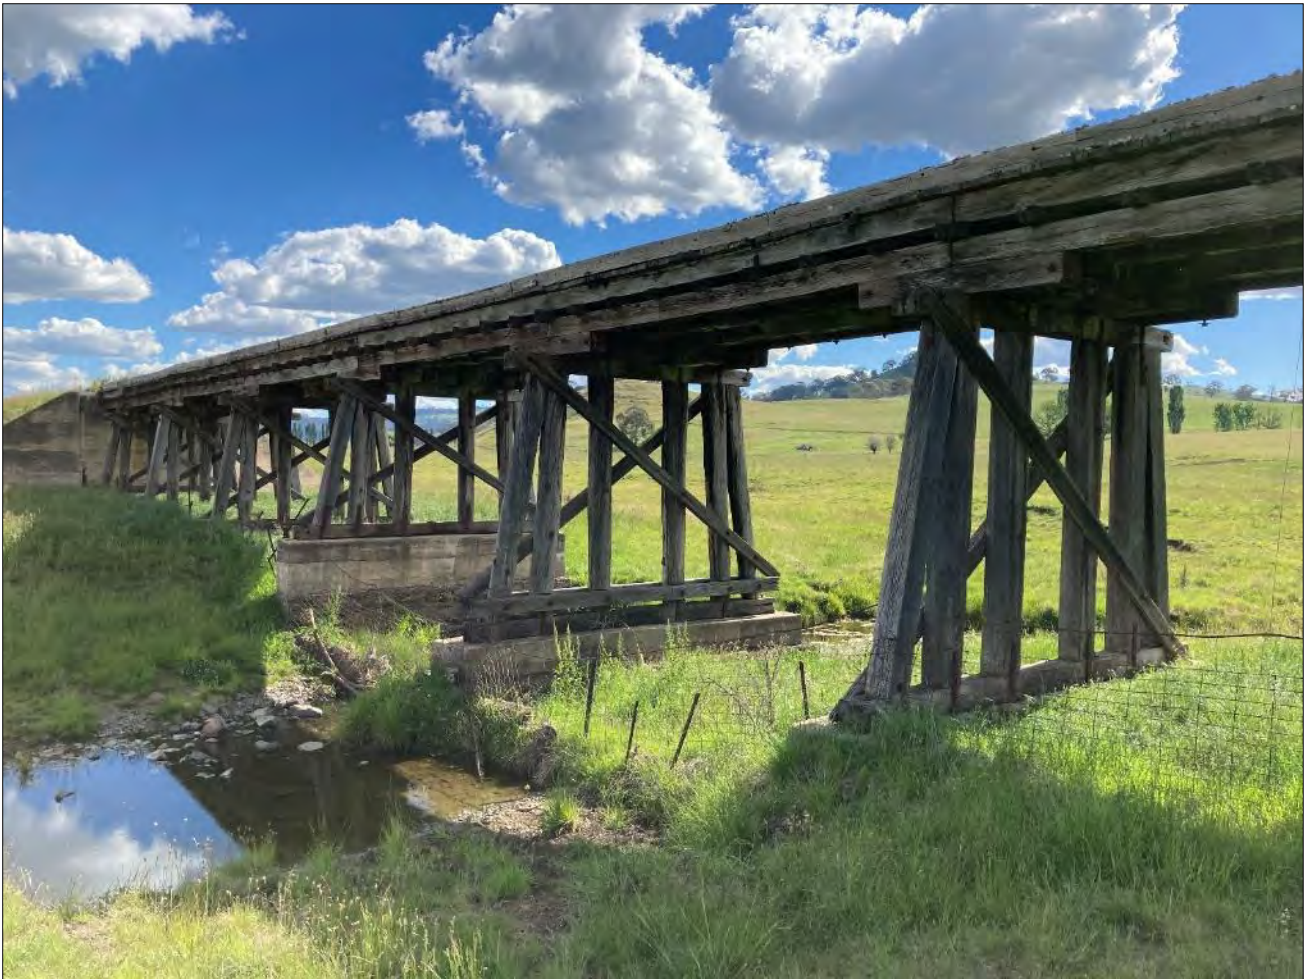
**Figure 5-10: View of Manrowan Creek from Abutment 2 side of the creek. Note the fence attached to the bridge which can have a negative impact on the bridge due to the increased chance of debris getting trapped and thus the lateral loads on the bridge increase.**

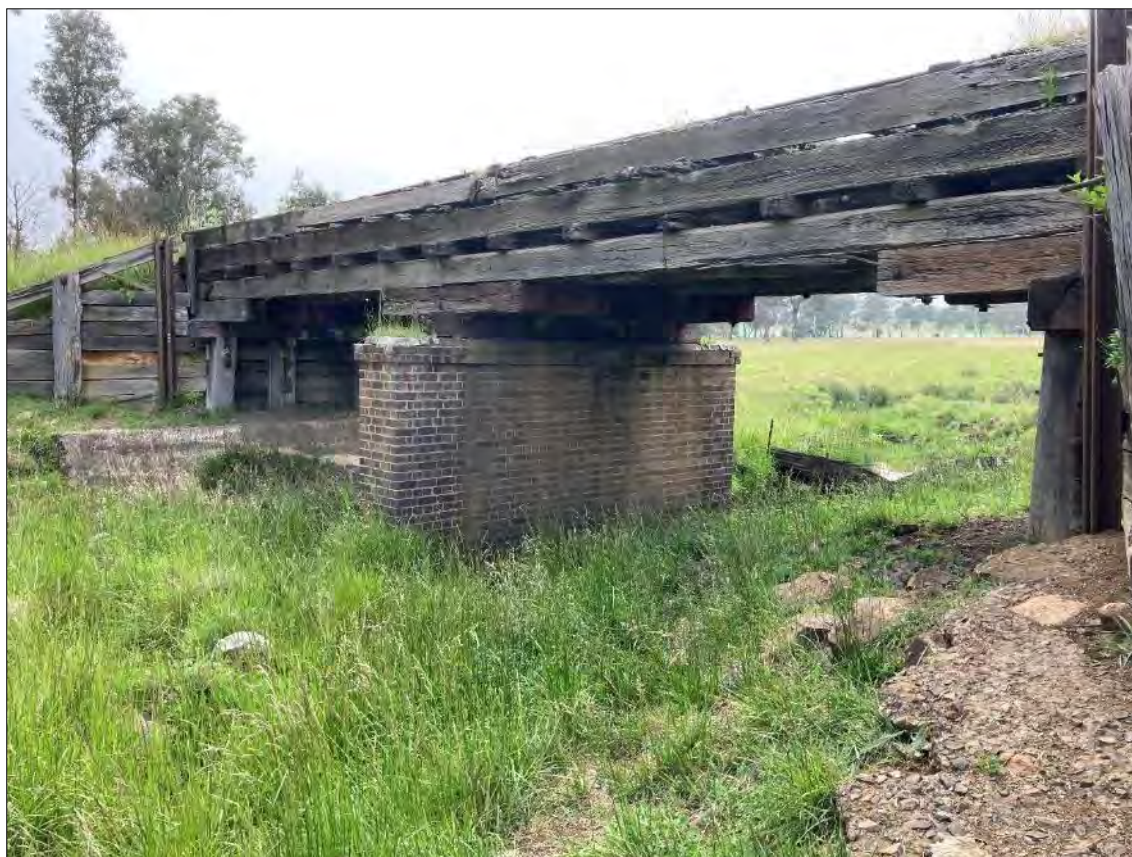
**Figure 6-1: View of Upper Williams Creek Bridge from Abutment 1 end of the bridge. Abutment 1 (Southern end) is to the right side of the image above. The natural flow of the creek is through span 2 with no water flow at the time of inspection. The configuration and current condition of the bridge is similar to Manrowan Creek Bridge with a beautiful brick pier (which can be saved to protect the construction of the era) instead of timber bents. The timber bridge is only 2 spans long and approximately 14 metres in length.**

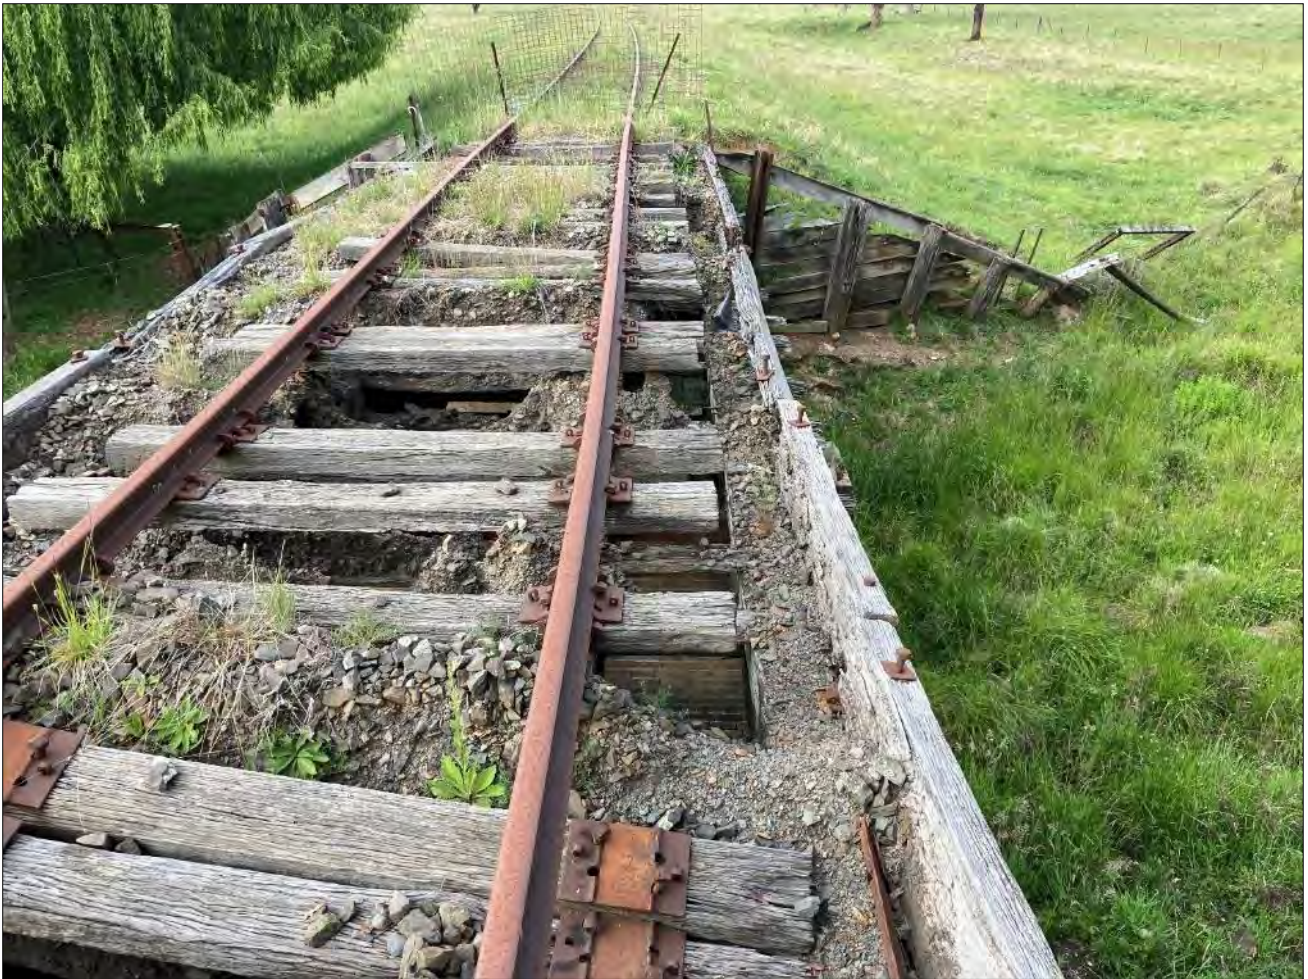
**Figure 6-2: The deck planks that support the ballast rock are in very poor condition with many of the planks missing and large amounts of ballast have fallen out.**

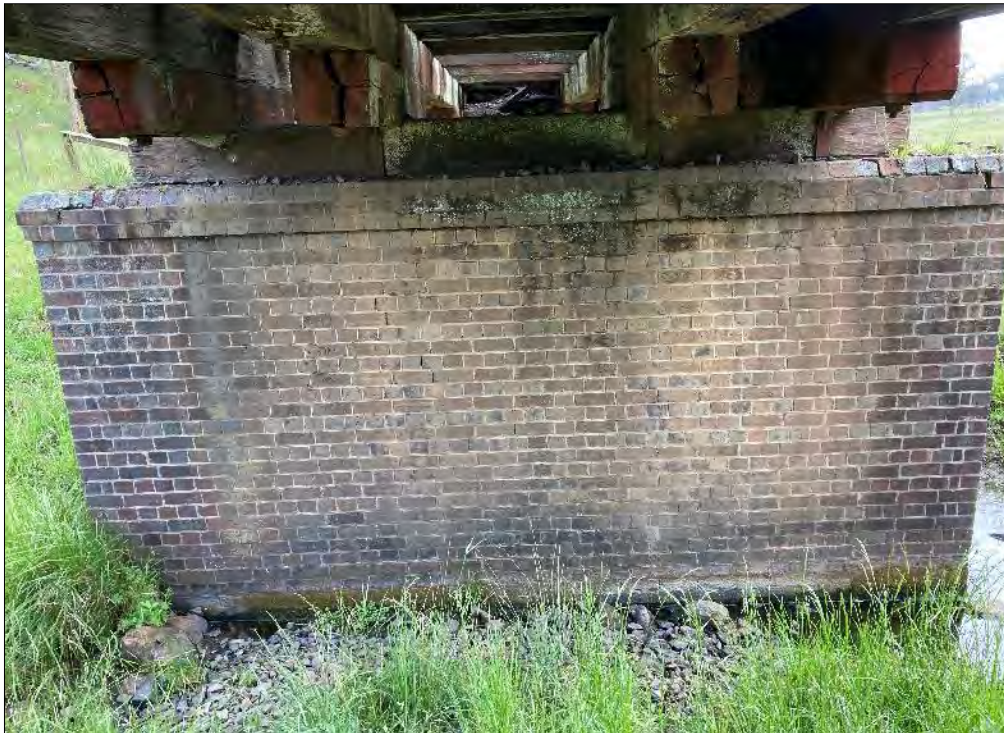
**Figure 6-3:** View of the brick pier that is approximately 3 metres in height. The timber girders are supported by corbels that rest on a timber cap that bears directly on the brick pier. On either side of the pier there are signs of deterioration and scour. Scour protection (rip rap) is recommended to be installed.
