# New England Rail Trail

## Trail Development Plans

Armidale – Black Mountain  
Ben Lomond – Glen Innes

## FINAL REPORT

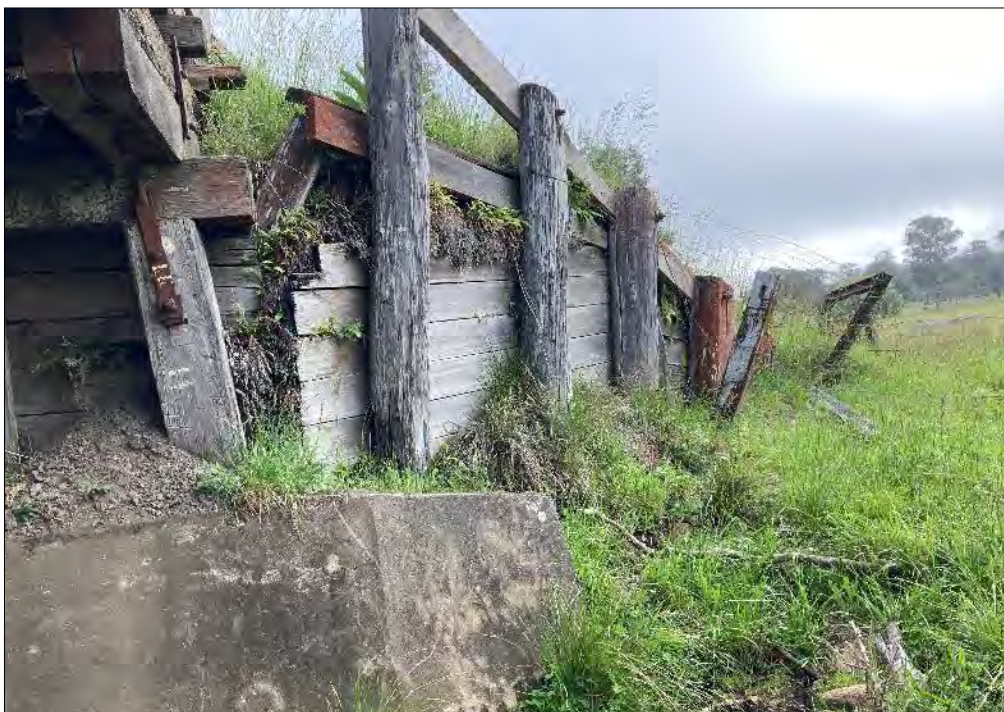
**Figure 6-4:** View of the typical abutment wingwall configuration and condition. The timber breastwall and wingwall planks have undergone significant deterioration and are now leaning 'outwards'. There is a loss of fines and larger aggregate from the approach through the breastwall.

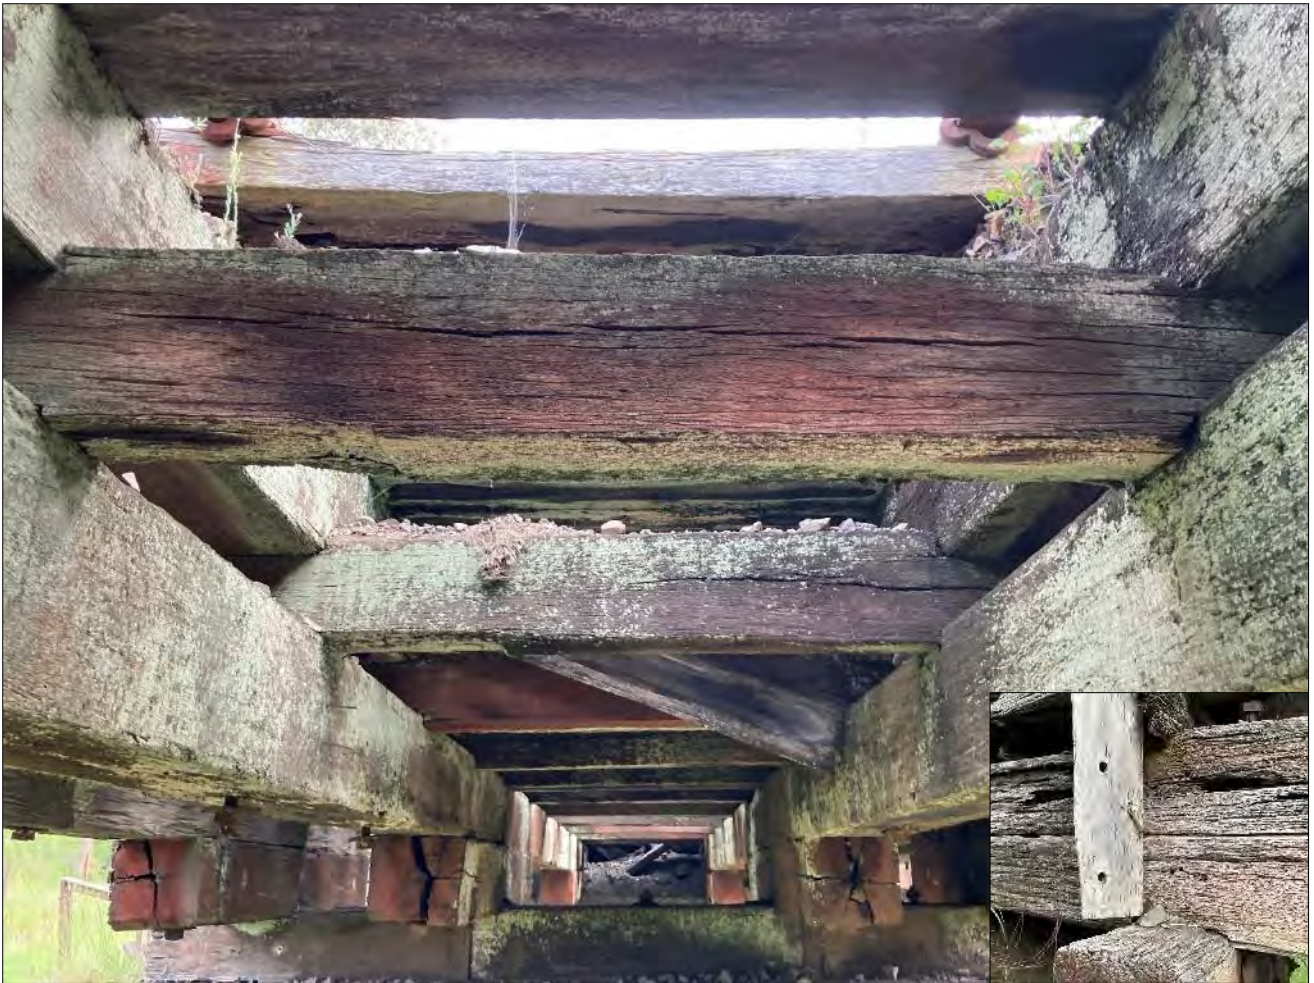
**Figure 6-5: A view of the underneath section of the bridge. It can be seen that the deck has collapsed in sections along the bridge. These planks will require replacement before the bridge can be reopened for pedestrian and cycle use. The superstructure comprises of 4 girder lines per span with the 2 girders per a girder line (8 girders per span in total). The double stacked sawn square girders are separated by traverse beams that contribute to the load sharing ability of the superstructure. Several of the girders has undergone significant deterioration with large splits visible from the underneath. The girders and corbels are connected with large vertical through bolts. Vertical fasteners increase the rate of decay in timber as they allow moisture to travel down the fastener into the heartwood of the girders and corbels where evaporation is more difficult, therefore increasing the moisture content in the middle of these elements over longer periods of time. The heartwood of a large dimensional element is less capable of breathing and expelling moisture than the sapwood that surrounds it, so vertical connectors funnel the moisture directly into the heartwood accelerating decay. Once the moisture content exceeds 22%, timber consuming fungi are activated and the decay process begins. Refer to Figure 3-2 for a detailed description of how and where the decay occurs due to these vertical bolts.**

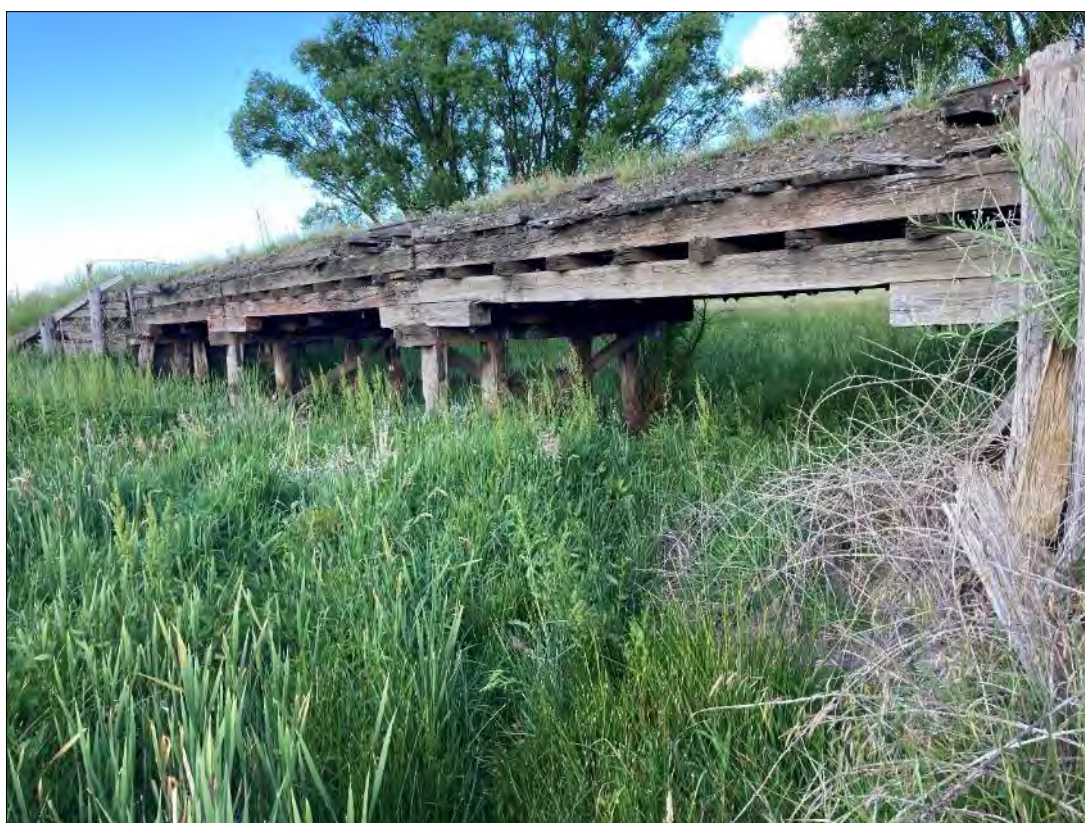
**Figure 7-1: View of Williams Creek from Abutment 1 end of the structure. The 3 span, 24m long bridge has the same superstructure and deck configuration as Manrowan Creek Bridge with timber pile bents. There is a large amount of vegetation growth around the bridge which keeps the moisture content high in the timber. When the moisture level in the timber is above 22%, decay-causing fungi can start to grow; when the moisture content drops below this level, the fungi become dormant and decay will be arrested until the moisture content rises again.**

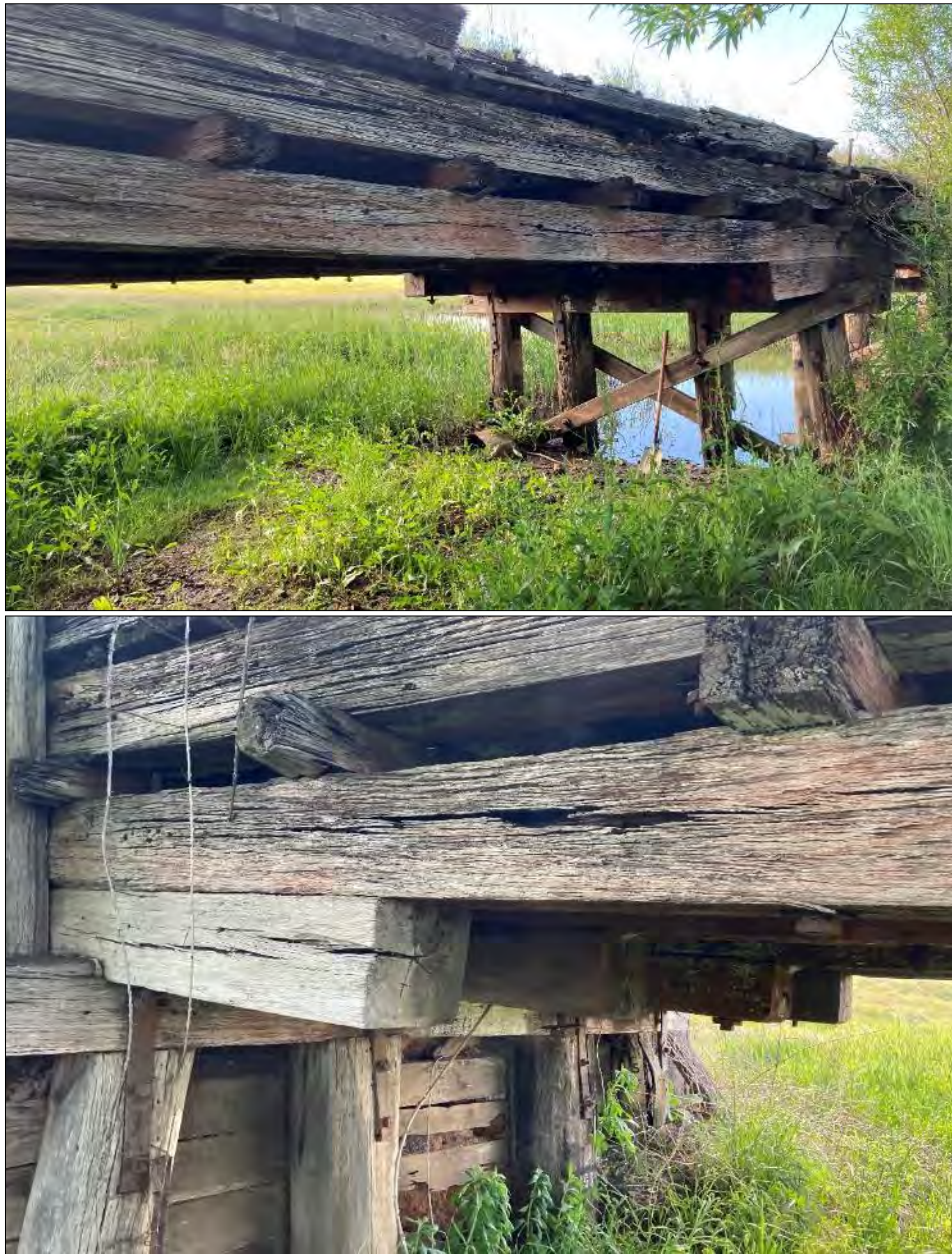
**Figure 7-2: The superstructure and deck are the same configuration and similar condition as Manrowan Creek Bridge. The girders are in very poor condition with Girder 4 in Span 1 having visible cavities and excessively deflecting under its own deadload which has result in full length cracking.**

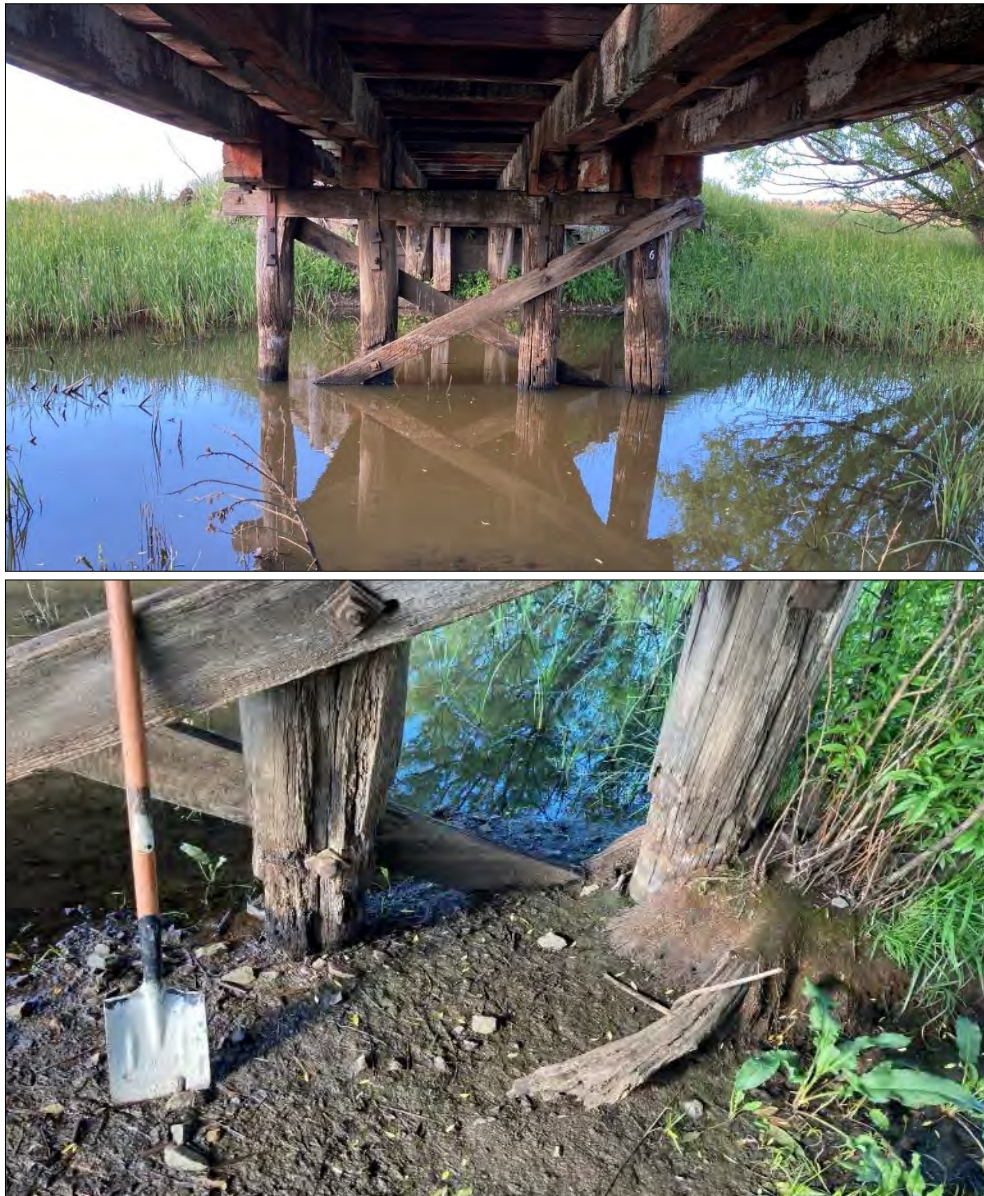
**Figure 7-3: View of Pile Bent 2 (top) and Piles 3 & 4 of Pile Bent 1. The bottom of the piles in the ‘splash’ zone are significantly deteriorated with major repairs required. These piles will also require restoration for lateral stability of the bridge. When more than 50% of the piles in the bent require replacing then it is cost effective and beneficial for longevity that the pile bent is replaced with a new frame bent. That is, all piles are trimmed down to bright (solid) wood and a new bottom cap (sill) is placed on top of the pile stubs with the new posts connected to the sill to support the new cap and corbels/girders.**

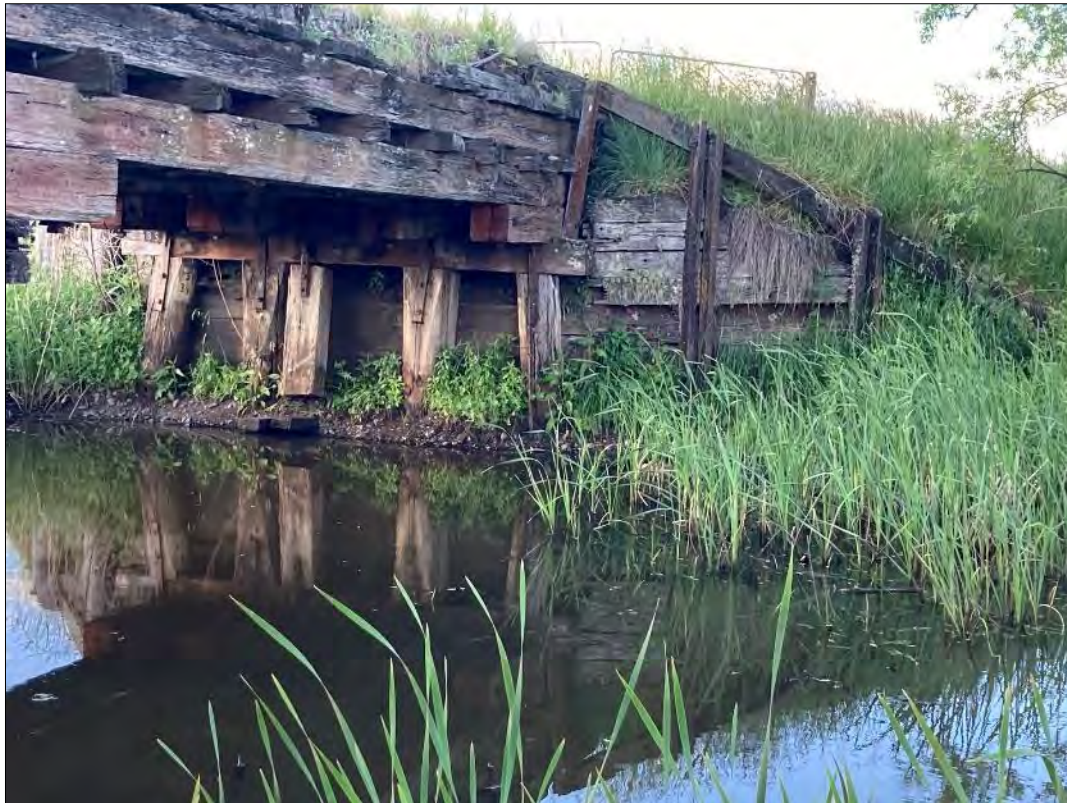
**Figure 7-4:** View of the typical abutment wingwall configuration and condition. The timber breastwall and wingwall planks have undergone significant deterioration and are now leaning ‘outwards’. There is a loss of fines and larger aggregate from the approach through the breastwall. Also note the very poor condition of the Abutment 2 piles where the central pile is ‘suspended’.

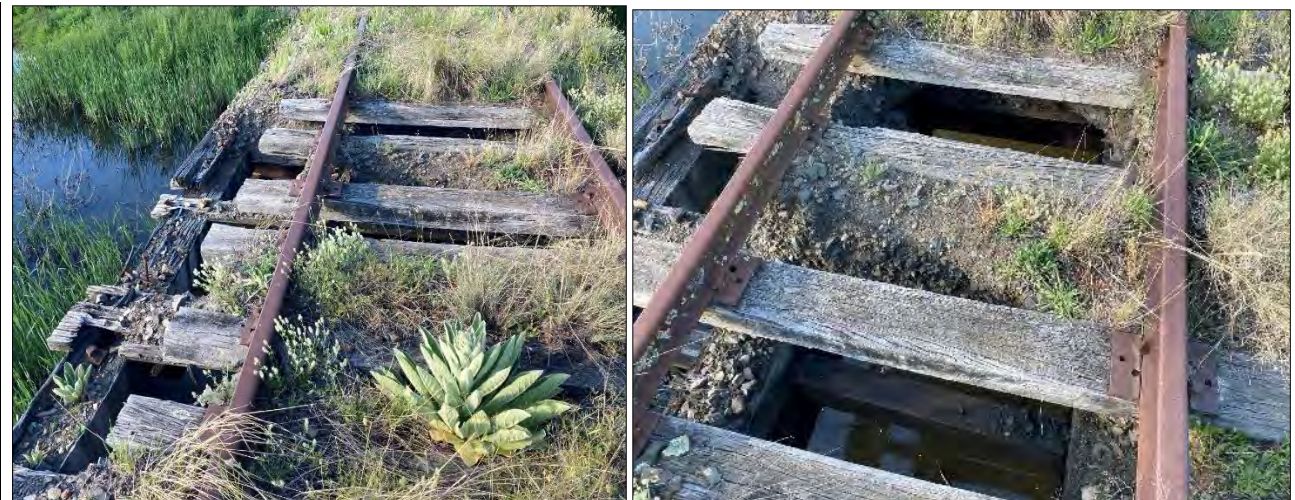
**Figure 7-5:** The deck planks that support the ballast rock are in very poor condition with many of the planks missing and large amounts of ballast have fallen out. To meet the current standards and Australian codes; vertical balustrade panels and a 1.4m high cycle rail will need to be installed along with a new deck system.

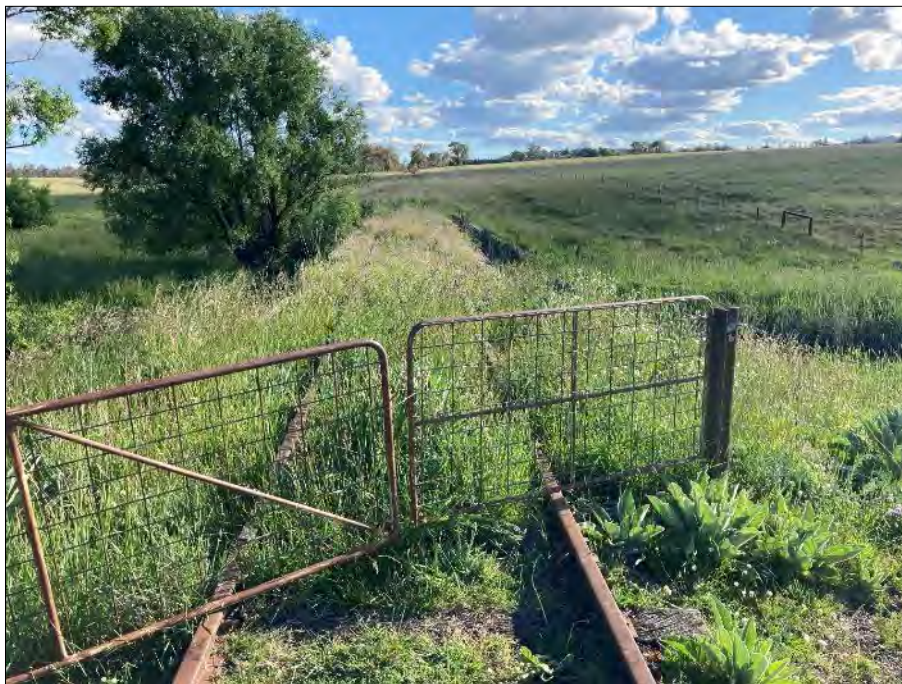
**Figure 7-7: View from Abutment 2 end of the bridge. The vegetation overgrowth is again evident from this image as there is a large tree growing on the upstream side of the bridge.**

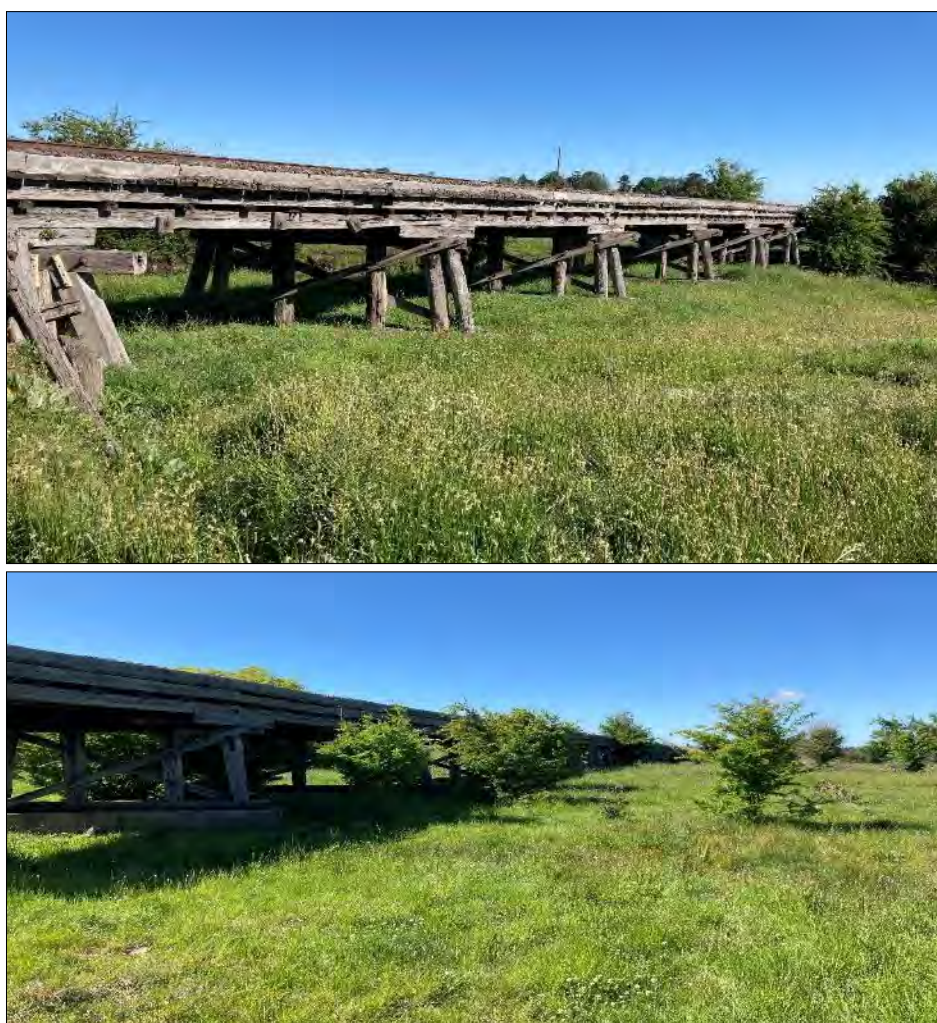
**Figure 8-1: Top image is the view of Beardy Waters Bridge from Abutment 1 and the bottom image is from Abutment 2. The timber bridge is 14 spans long and approximately 112 metres in length (8 metre long spans). Note several of the spans at Abutment 2 side of the river are in very poor (unsafe) condition and have partially collapsed and sunken.**

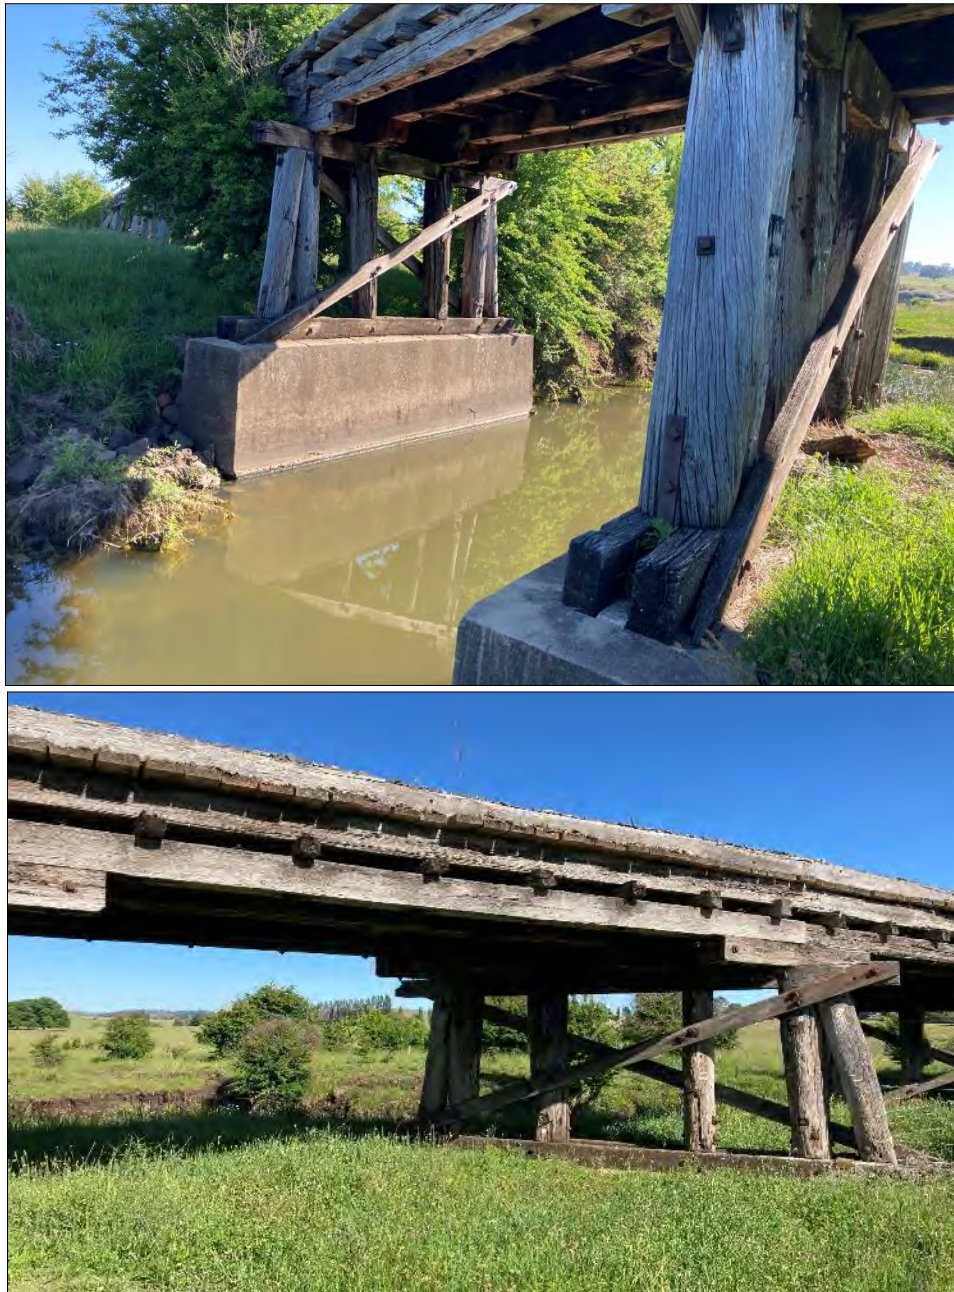
**Figure 8-2: View of the typical timber pile bent configuration. The bent comprises of 6 square (or round) dimensional post bearing directly on a timber bottom cap which is vertically connected to the concrete footing. The bent is also supported by cross bracing that provides adequately support for the 2.5-4m long posts. Overall the timber bents were found to be in a poor to very poor condition with the timber bottom caps being in the worst condition. This is as per expected due to the timber bearing directly on the concrete footing which typically has a high moisture content. Over time the timber post undergoes capillary action and draws up the moisture like a ‘straw’. Once the moisture content in the timber elements reaches 22%, decay causing fungi are activated and the decay process begins. This timber bottom cap has partially ‘protected’ the timber posts which are in relatively poor condition, however the timber cap wales will cost a significant amount to be replaced or repaired in-situ. Also note the bents are heavily skewed (approximately 30 degrees) and are parallel with the stream.**

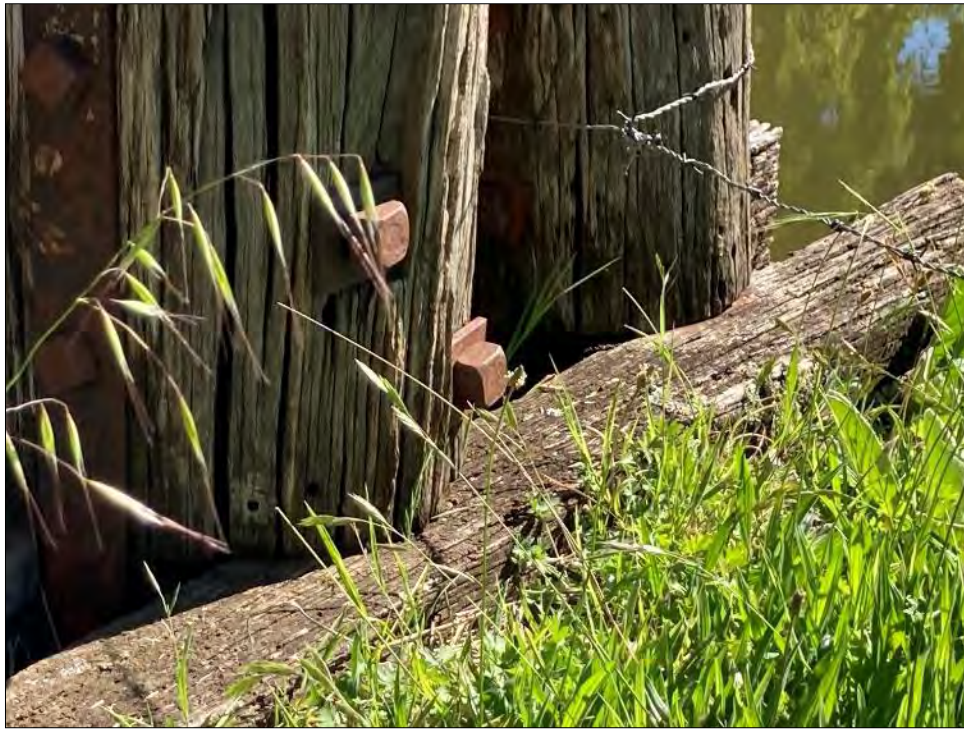
**Figure 8-3:** It was noted that the bottom section of several posts and timber cap wales have started to undergo decay. This is as expected due to the timber posts bearing directly on the concrete footing which typically has a high moisture content. Over time the timber post undergoes capillary action and draws up the moisture like a ‘straw’. Once the moisture content in the timber elements reaches 22%, decay causing fungi are activated and the decay process begins. Overall the timber bents were found to be in poor condition. The bottom sections of the timber piles were determined to be a ‘hotspot’ for decay and determined to be an ideal area to test using non-destructive methods, such as EPHOD® Stress Wave Technology. Refer to Appendix B for more information of this type of testing method. A reading of above 1500 $\mu$ s was recorded for the time taken for the compression wave to travel across the section of the member tested. This was recorded at the bottom of one of the piles (left image above) and was found to be similar across most of the piles/posts. Deterioration of this magnitude means that the Modulus of Elasticity/Modulus of Rupture in various stress directions (wood is anisotropic with different strength properties in different directions) has deteriorated to an extent that the element can no longer support its own dead weight. Readings between 1000 $\mu$ s and 2200 $\mu$ s indicate that the member cannot carry its own dead weight in these regions. Readings in excess of 2200 $\mu$ s can signify a cavity while a reading above 3300 $\mu$ s indicates the element can no longer support its own dead load and is at risk of failing at any point.

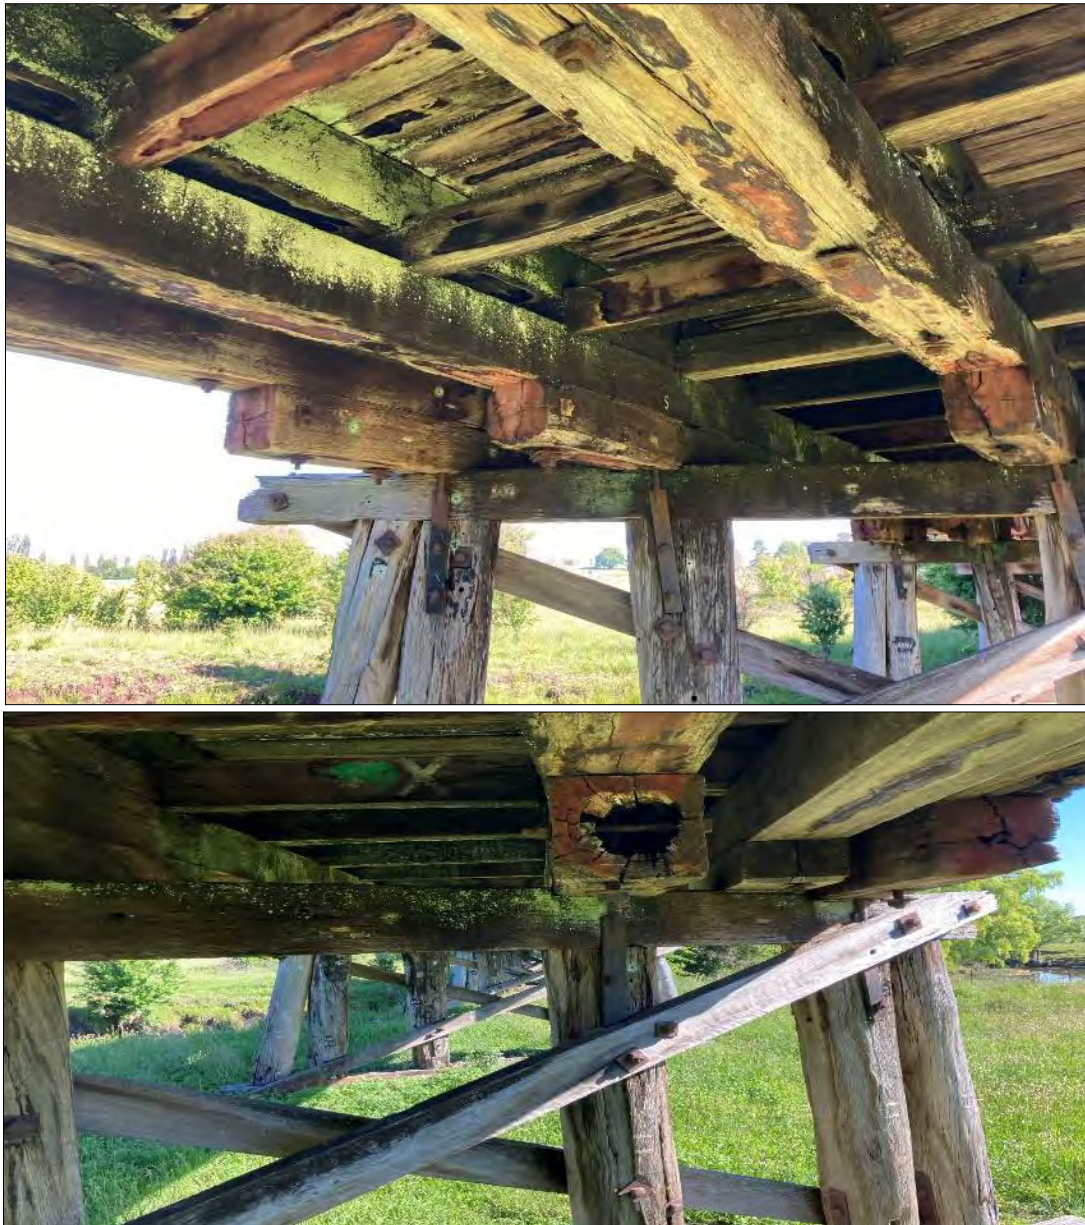
**Figure 8-4:** A view of the underneath section of the bridge. The superstructure comprises of 4 girder lines per span with the 2 girders per a girder line (8 girders per span in total). The double stacked square cut solid sawn girders are separated by traverse beams that contribute to the load sharing ability of the superstructure. Generally the transverse beams were in poor condition and the girders are in poor-very poor condition. One of the girders has undergone significant deterioration with large splits visible from the underneath as well as being covered fully in decay fungi growth. The girders and corbels are connected with large vertical through bolts. Vertical fasteners increase the rate of decay in timber as they allow moisture to travel down the fastener into the heartwood of the girders and corbels where evaporation is more difficult, therefore increasing the moisture content in the middle of these elements over longer periods of time. The heartwood of a large dimensional element is less capable of breathing and expelling moisture than the sapwood that surrounds it, so vertical connectors funnel the moisture directly into the heartwood accelerating decay. Once the moisture content exceeds 22%, timber consuming fungi are activated and the decay process begins. Refer to Figure 3-2 for a detailed description of how and where the decay occurs due to these vertical bolts.

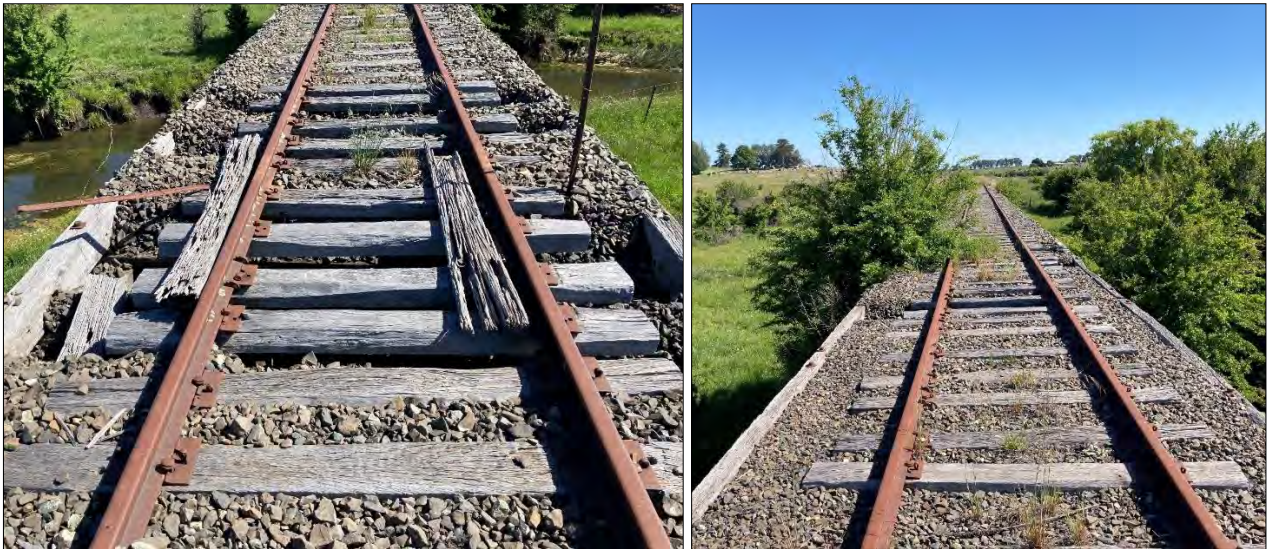
**Figure 8-5: The timber transoms (rail ties) were found to be in a poor condition. If the bridge was to be repurposed for pedestrian and cycle use the timber transoms, railway line and rock ballast would be required to be removed. The existing timber edge rail that contains the ballast can left in place to act as a kerb/kick rail in the re-purposed bridge. To meet the current standards and Australian codes; vertical balustrade panels and a 1.4m high cycle rail will need to be installed. The current width of the bridge from inside of kerb to inside of kerb is approximately 3.0 metres which will result in a code compliant width for pedestrian bridges. As many of the deck planks are ‘falling’ out a new deck would be required for this bridge. The rock ballast can be reused to create the trail.**

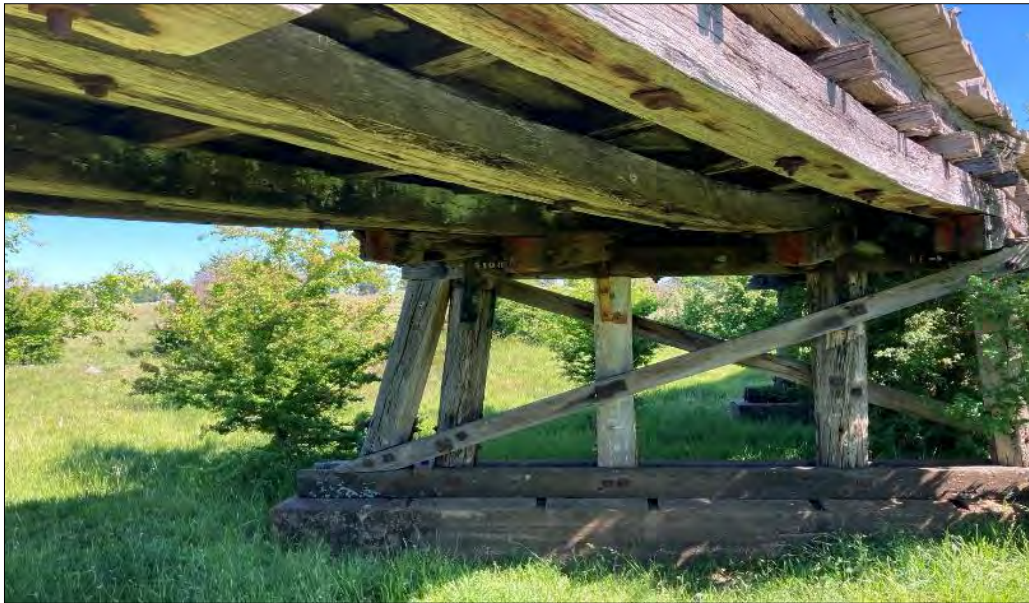
**Figure 8-7:** A view of a section of the bridge that has collapsed/sunken at Span 11. These members will require replacement before the bridge can be reopened for pedestrian and cycle use. The superstructure comprises of 4 girder lines per span with the 2 girders per a girder line (8 girders per span in total). The double stacked girders are separated by traverse beams that contribute to the load sharing ability of the superstructure.

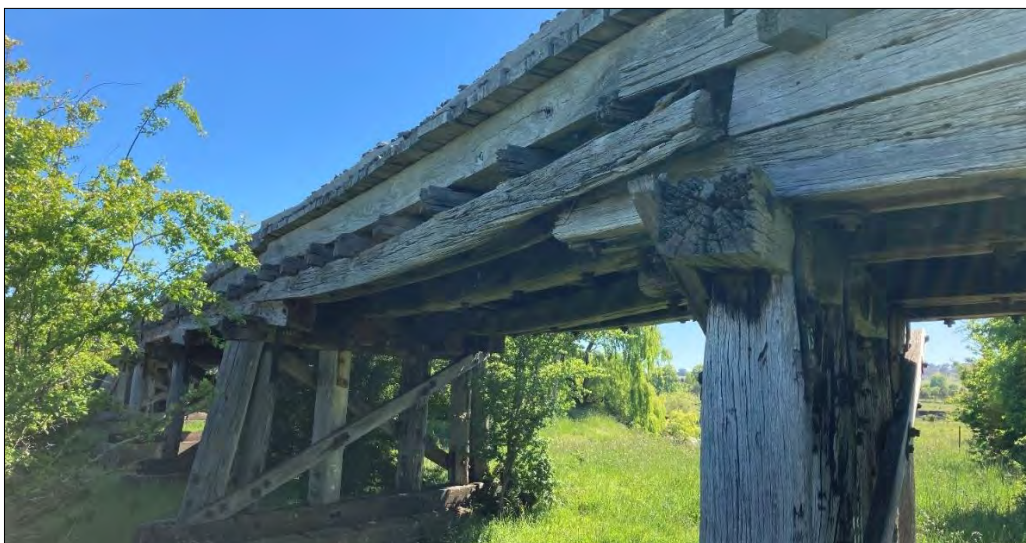
**Figure 8-8:** Another view of a section of the bridge that has collapsed/sunken due to the girder and corbel 'crushing' due to significant decay. The girders and corbels are connected down to the cap with a vertical through bolt. Vertical fasteners increase the rate of decay in timber as they allow moisture to travel down the fastener into the heartwood of the girders and corbels where evaporation is more difficult, therefore increasing the moisture content in the middle of these elements over longer periods of time. The heartwood of a large dimensional element is less capable of breathing and expelling moisture than the sapwood that surrounds it, so vertical connectors funnel the moisture directly into the heartwood accelerating decay. Once the moisture content exceeds 22%, timber consuming fungi are activated and the decay process begins. Refer to Figure 3-2 for a detailed description of how and where the decay occurs due to these vertical bolts.

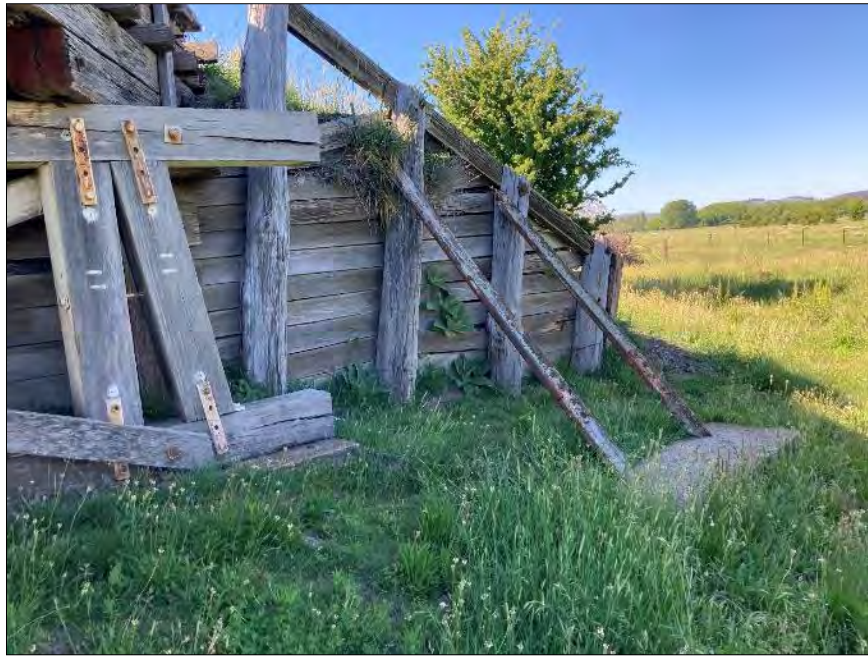
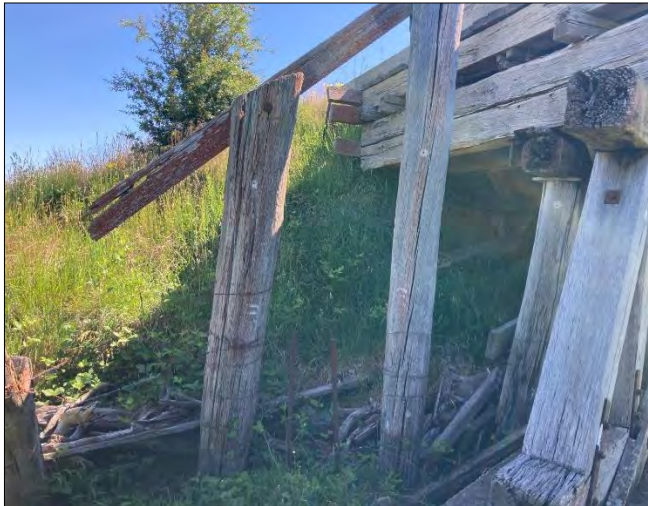
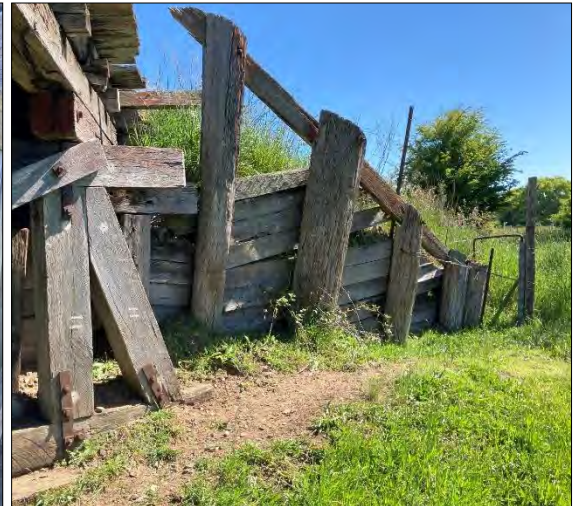
**Figure 8-9: View of the typical abutment wingwall configuration and condition. The timber breastwall and wingwall planks have undergone significant deterioration and are now leaning ‘outwards’. There is a loss of fines and larger aggregate from the approach through the breastwall. The top image is Abutment 1 with the bottom image Abutment 2.**

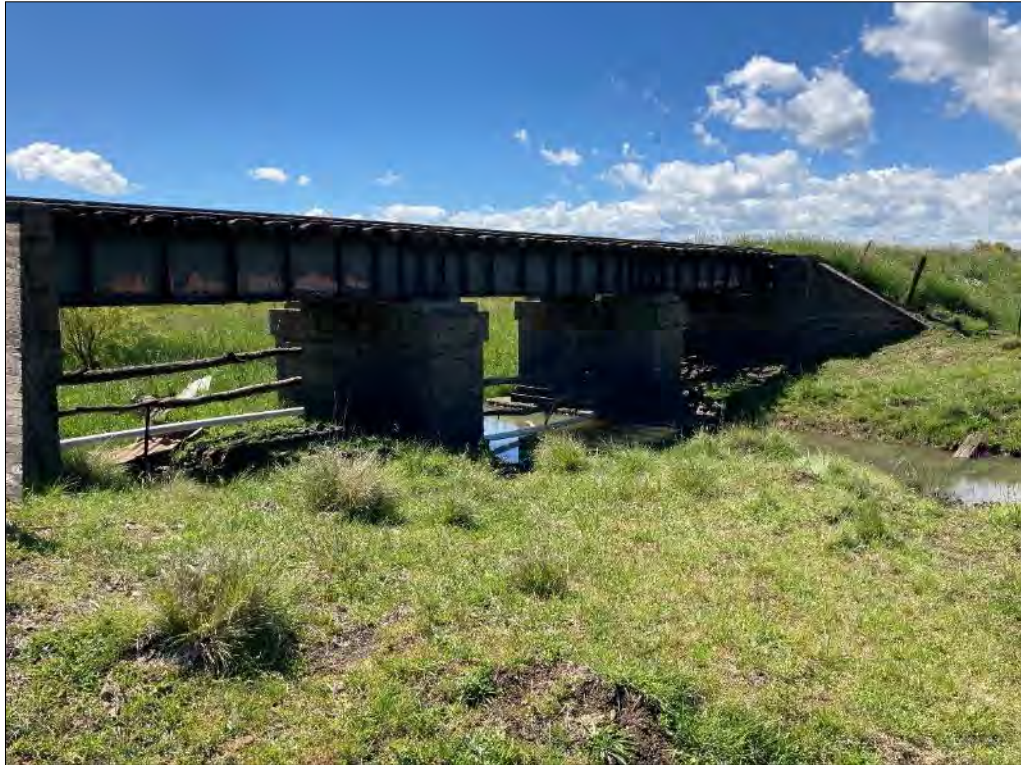
**Figure 9-1: View of Stonehenge Creek Bridge from Abutment 2 end of the bridge. Abutment 1 (Southern end) is to the right side of the image above. The natural flow of the creek is through span 2 with no water flow at the time of inspection. The configuration and current condition of the bridge is similar to Upper Williams Creek Bridge with the brick pier(s) however the girders are steel plated which is very common for railway bridges. The steel girder bridge is only 3 spans long and approximately 18 metres in length. The bridge piers can be saved for aesthetics.**

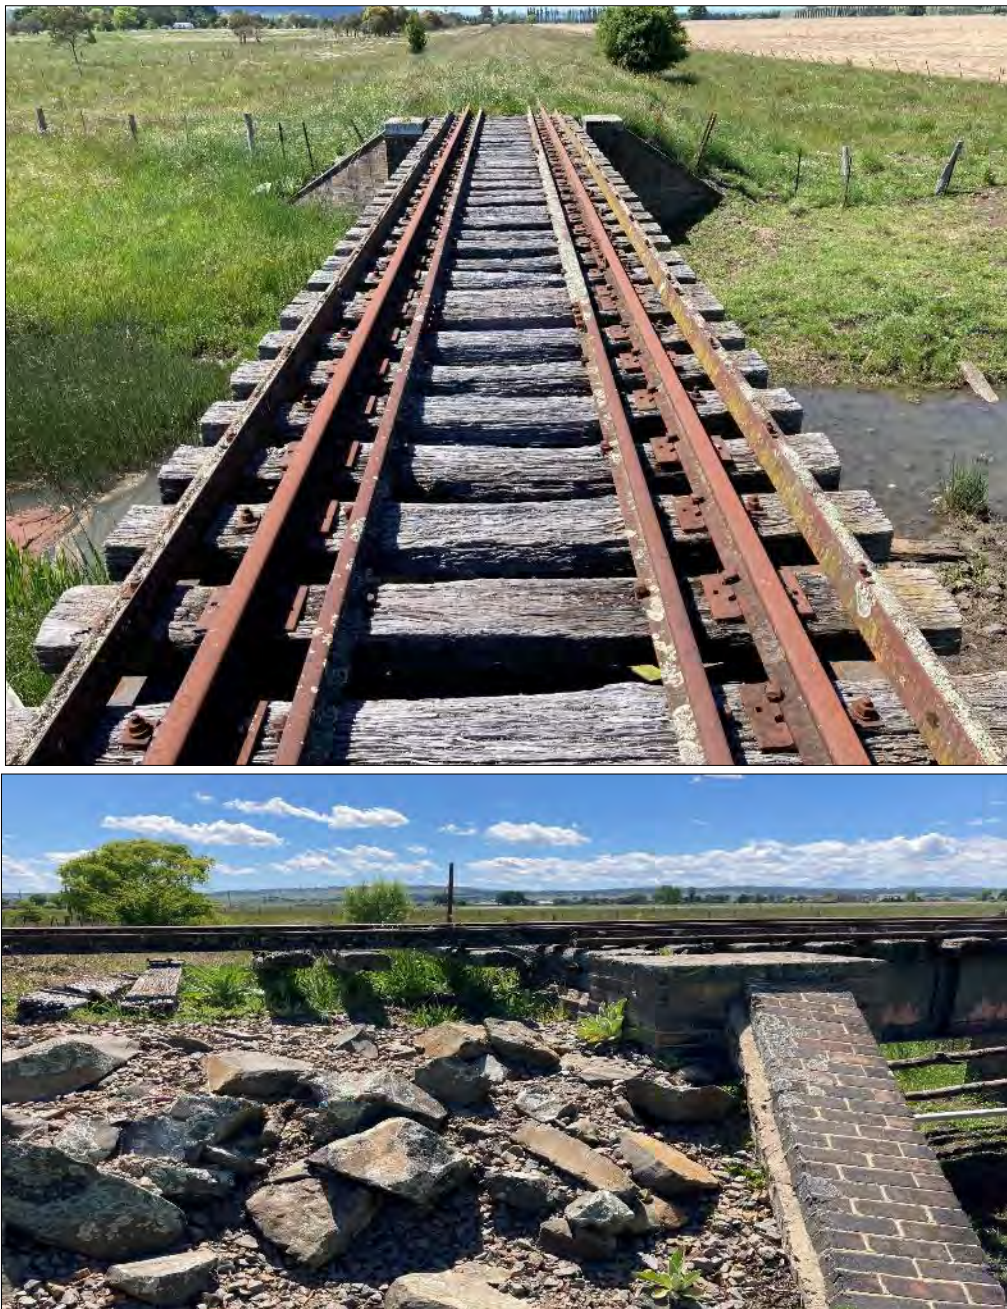
**Figure 9-2: The top image is a view of the bridge looking back towards Armidale. The timber transoms are connected directly to the steel plated girders. There has been erosion/scour at Abutment 2 with many of the transoms missing and large amounts of approach fill missing. Notice the inner guard rail is still intact!!**

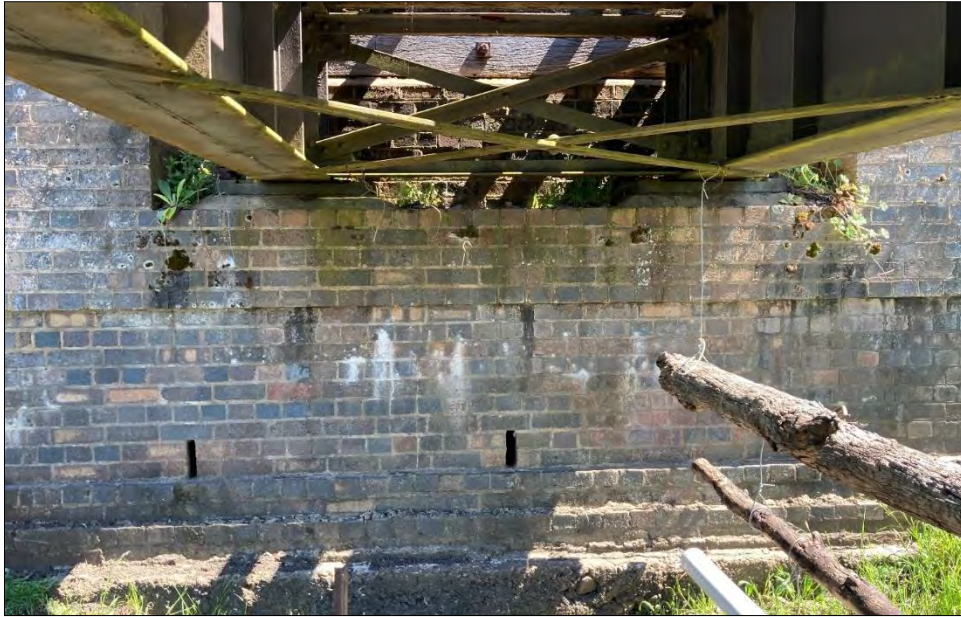
**Figure 9-3: View of the brick Abutment that is approximately 3 metres in height. The steel plated girders bear directly on the brick pier. The girders are lateral supported by transverse and diagonal bracing. The substructure can be preserved.**

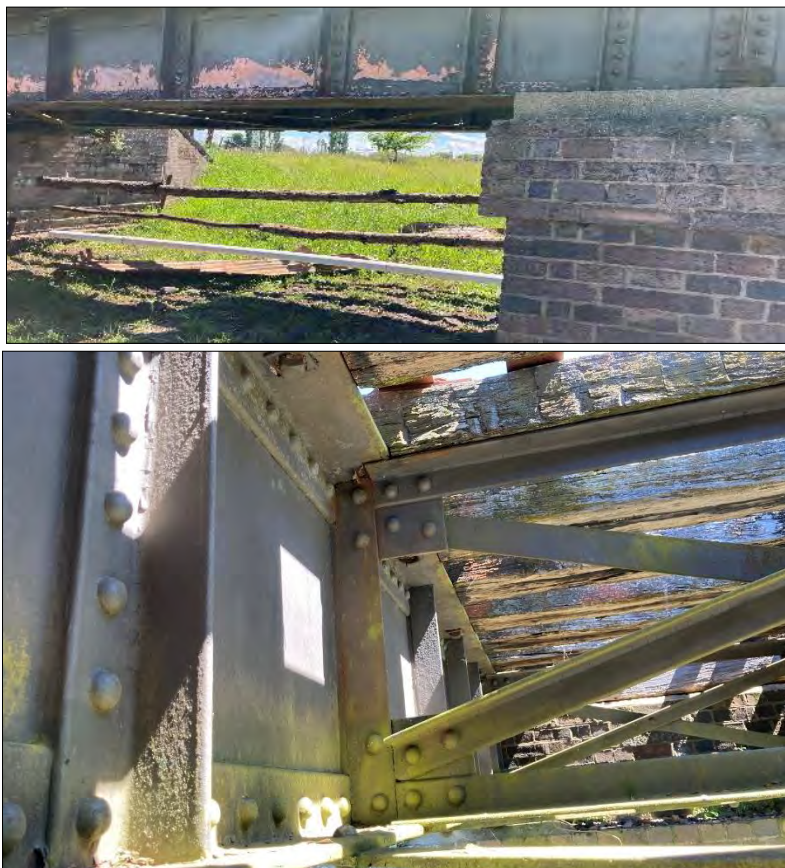
**Figure 9-4: The steel is starting to show signs of corrosion with maintenance required for the steel plated beams. A lightweight deck system on-top of the girders will be the recommended repair solution for this bridge combined with steel repairs.**

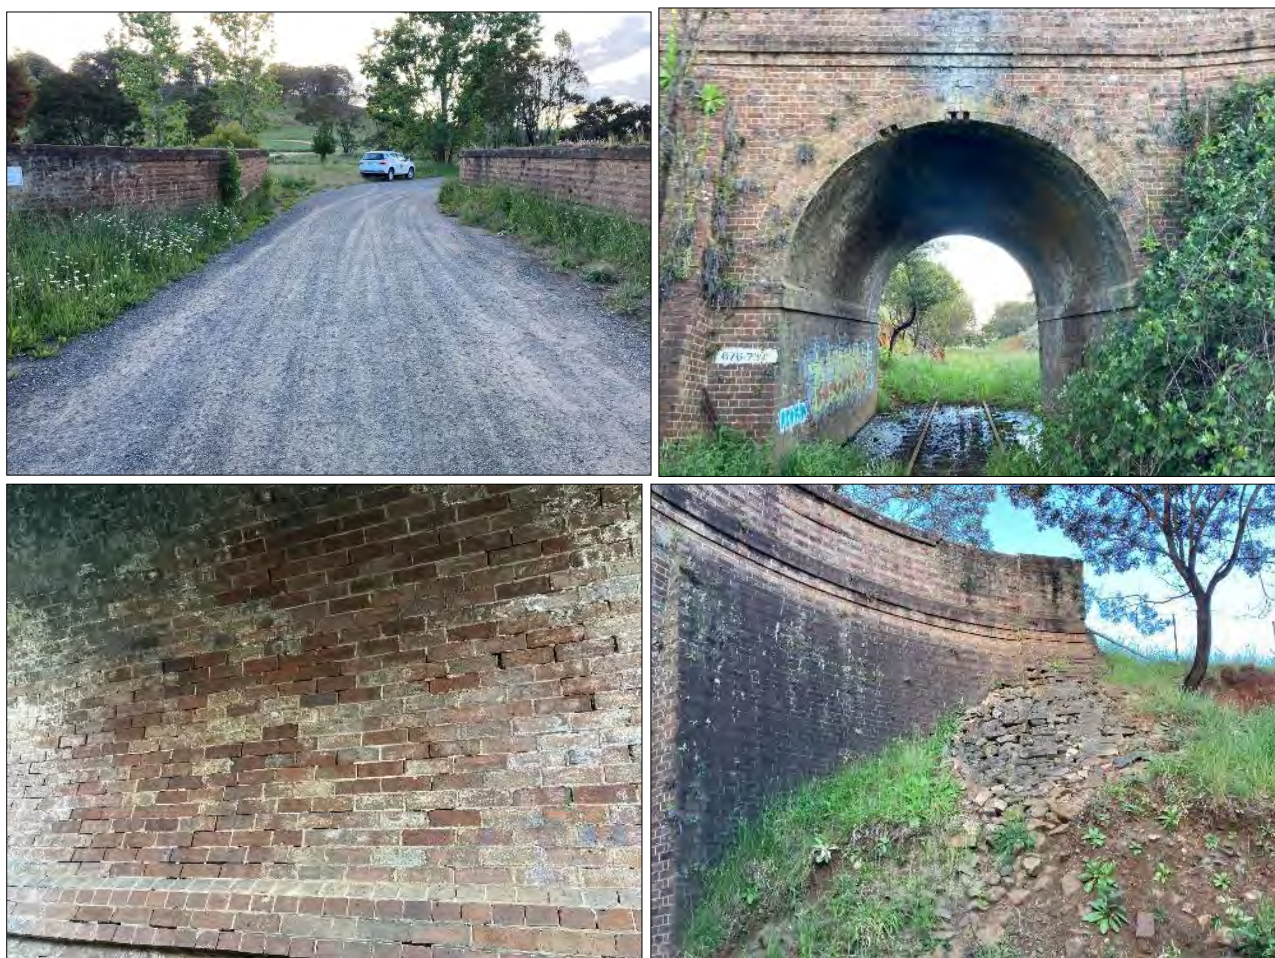
**Figure 10-1: View of Crotty Road brick arch overpass bridge. This bridge is located just off the New England Highway and can be a major attraction to the trail given its historic features. The archway under the bridge is in fair to poor condition and with minor maintenance can be restored to accommodate pedestrians walking through.**
