# New England Rail Trail

## Trail Development Plans

Armidale – Black Mountain  
Ben Lomond – Glen Innes

## FINAL REPORT

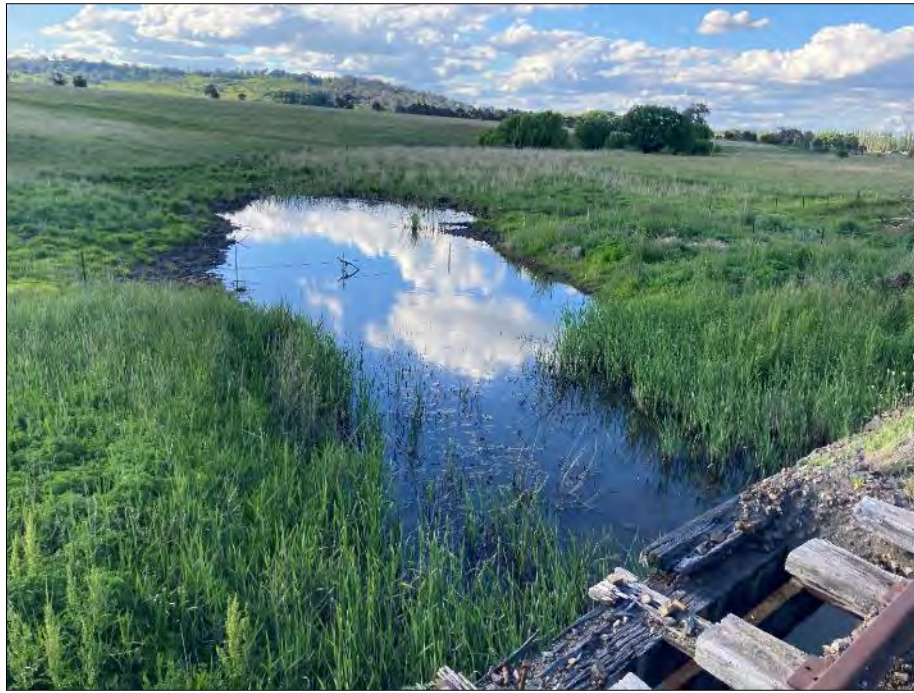
**Figure 7-6: A view of the creek downstream. At the time of inspection the water was not flowing.**

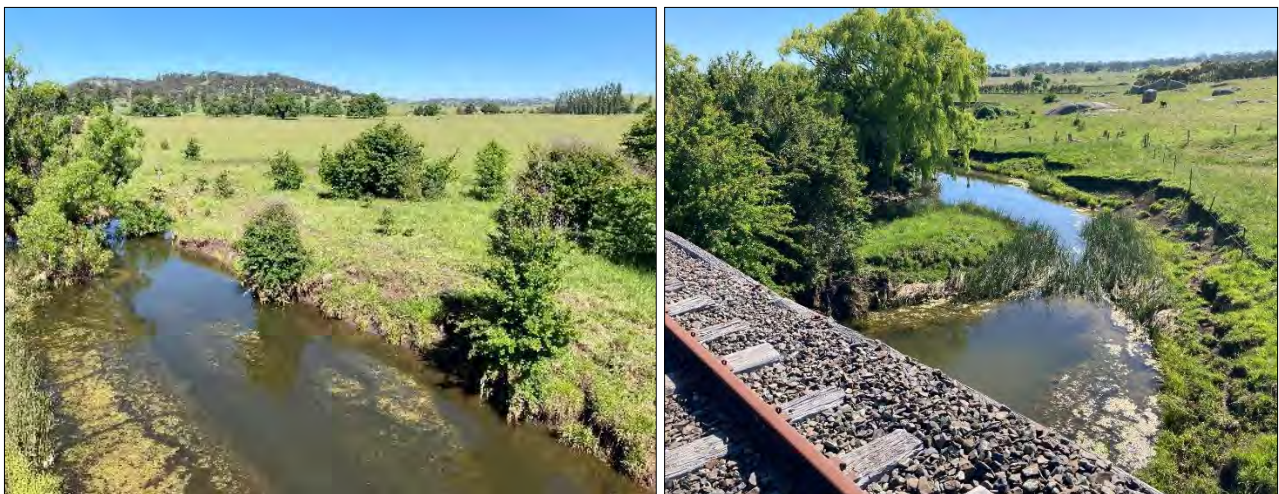
**Figure 8-6: View of the stream upstream (left hand image) and downstream (right hand image).**

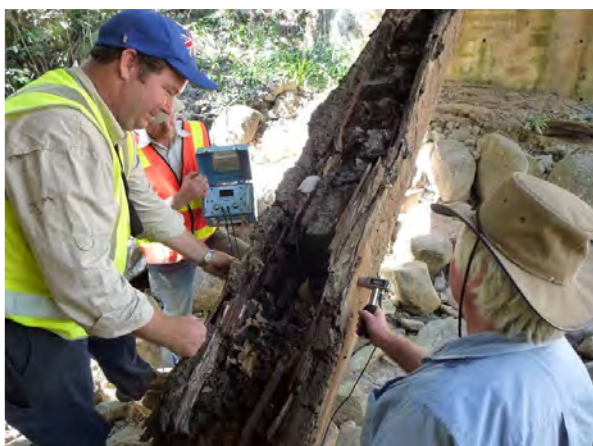
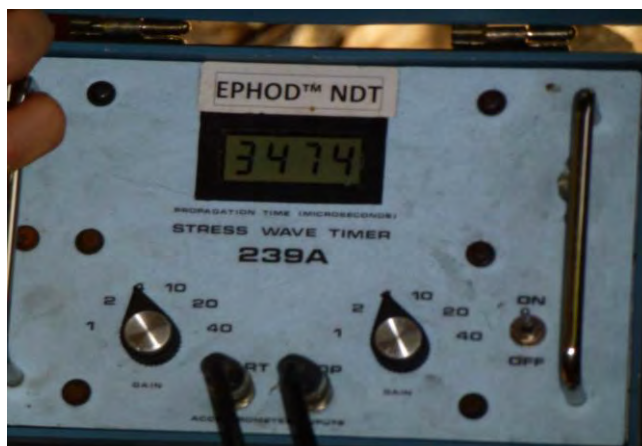
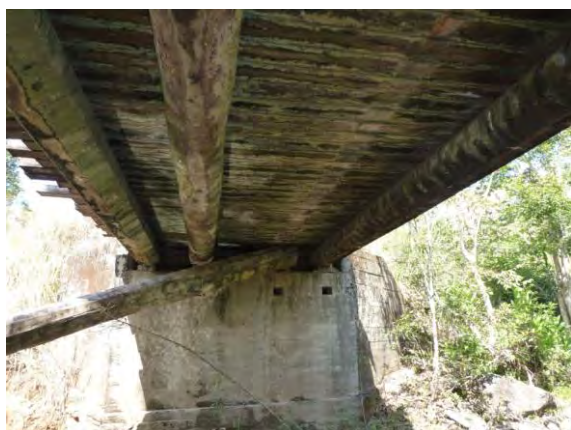
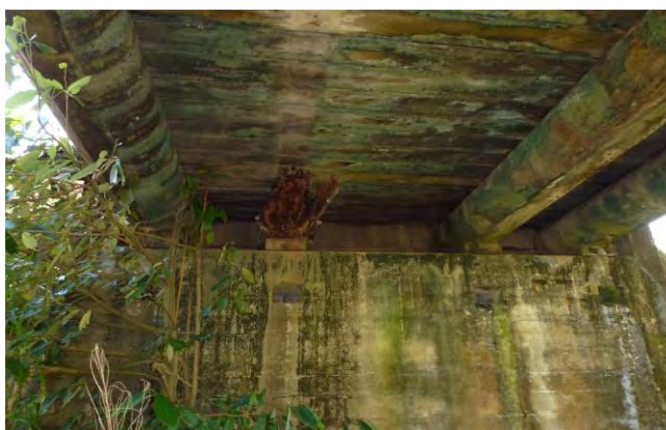
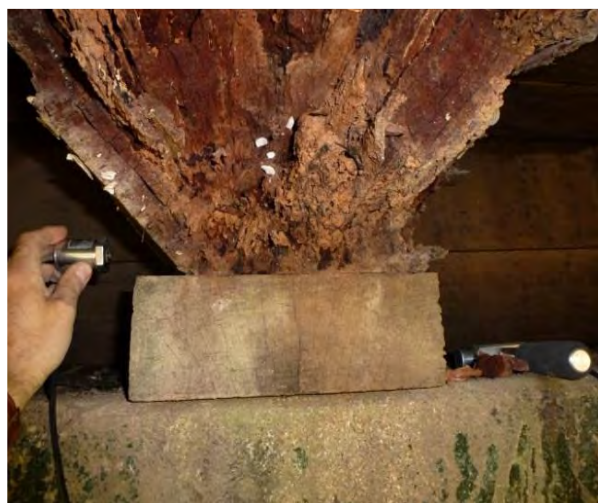
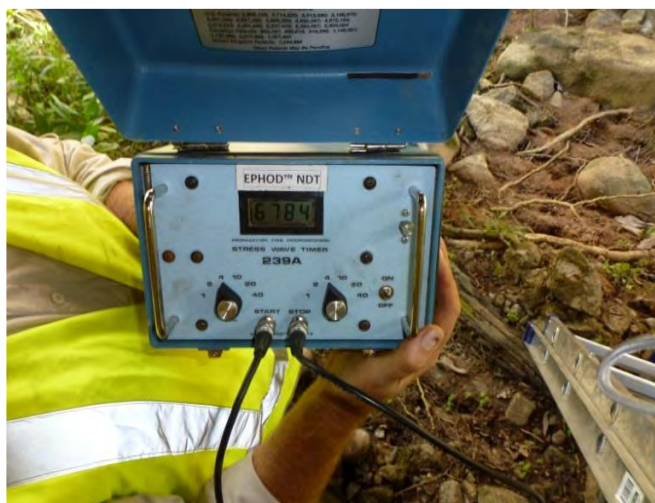
**Figure 11-1: Photos showing global failure of a timber log girders. Both failures were caused by advanced decay in the ends of the girders and transverse shear failures. The primary cause of this decay was due to vertical fasteners. These failures were found in elements with SWT values in the 3k  $\mu$ s (photos a. above) to 6k  $\mu$ s range (photos b. below). Typically similar bending extreme tensile fibre failures in log girders occur in zones of decay where there are over 2k  $\mu$ s SWT values. Similarly if vast portions of the log girder have SWT values over 3k  $\mu$ s the failures may occur.**

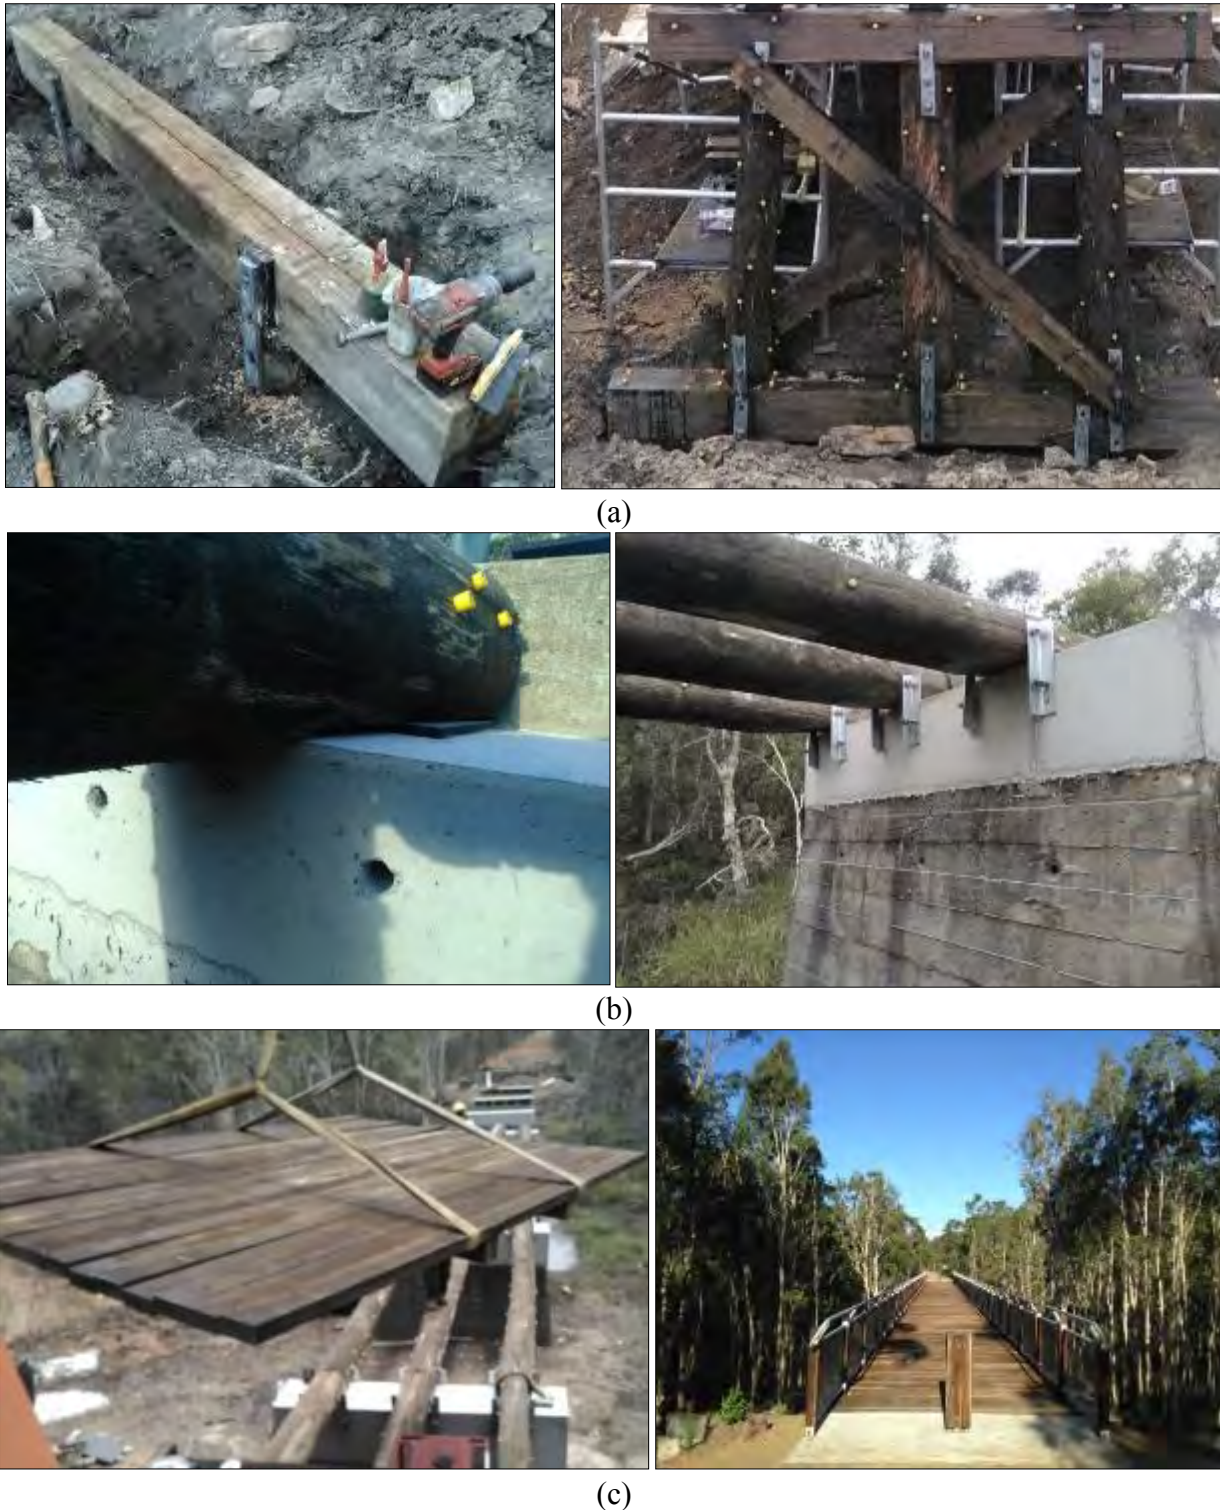
**Figure 11-3: The above photo series demonstrates Option 1 type of fix (hardwood) used for the construction of two Mary to Bay Rail Trail Bridges. Seen above in photo (a) is the construction of a frame bent using an intermediate cap which was installed on top of the existing pile stubs. This allowed the hardwood posts, cross bracing and cap to be installed at the correct reference height. Also note the yellow plugs that indicate that Decaystop® rods have been installed. Photo (b) shows the girders being installed using a horizontal connection system and a rubber liner between the timber girder and concrete pier. In photo (c) the pre-panelised deck is installed along with the modulus handrail and cycle rail system.**

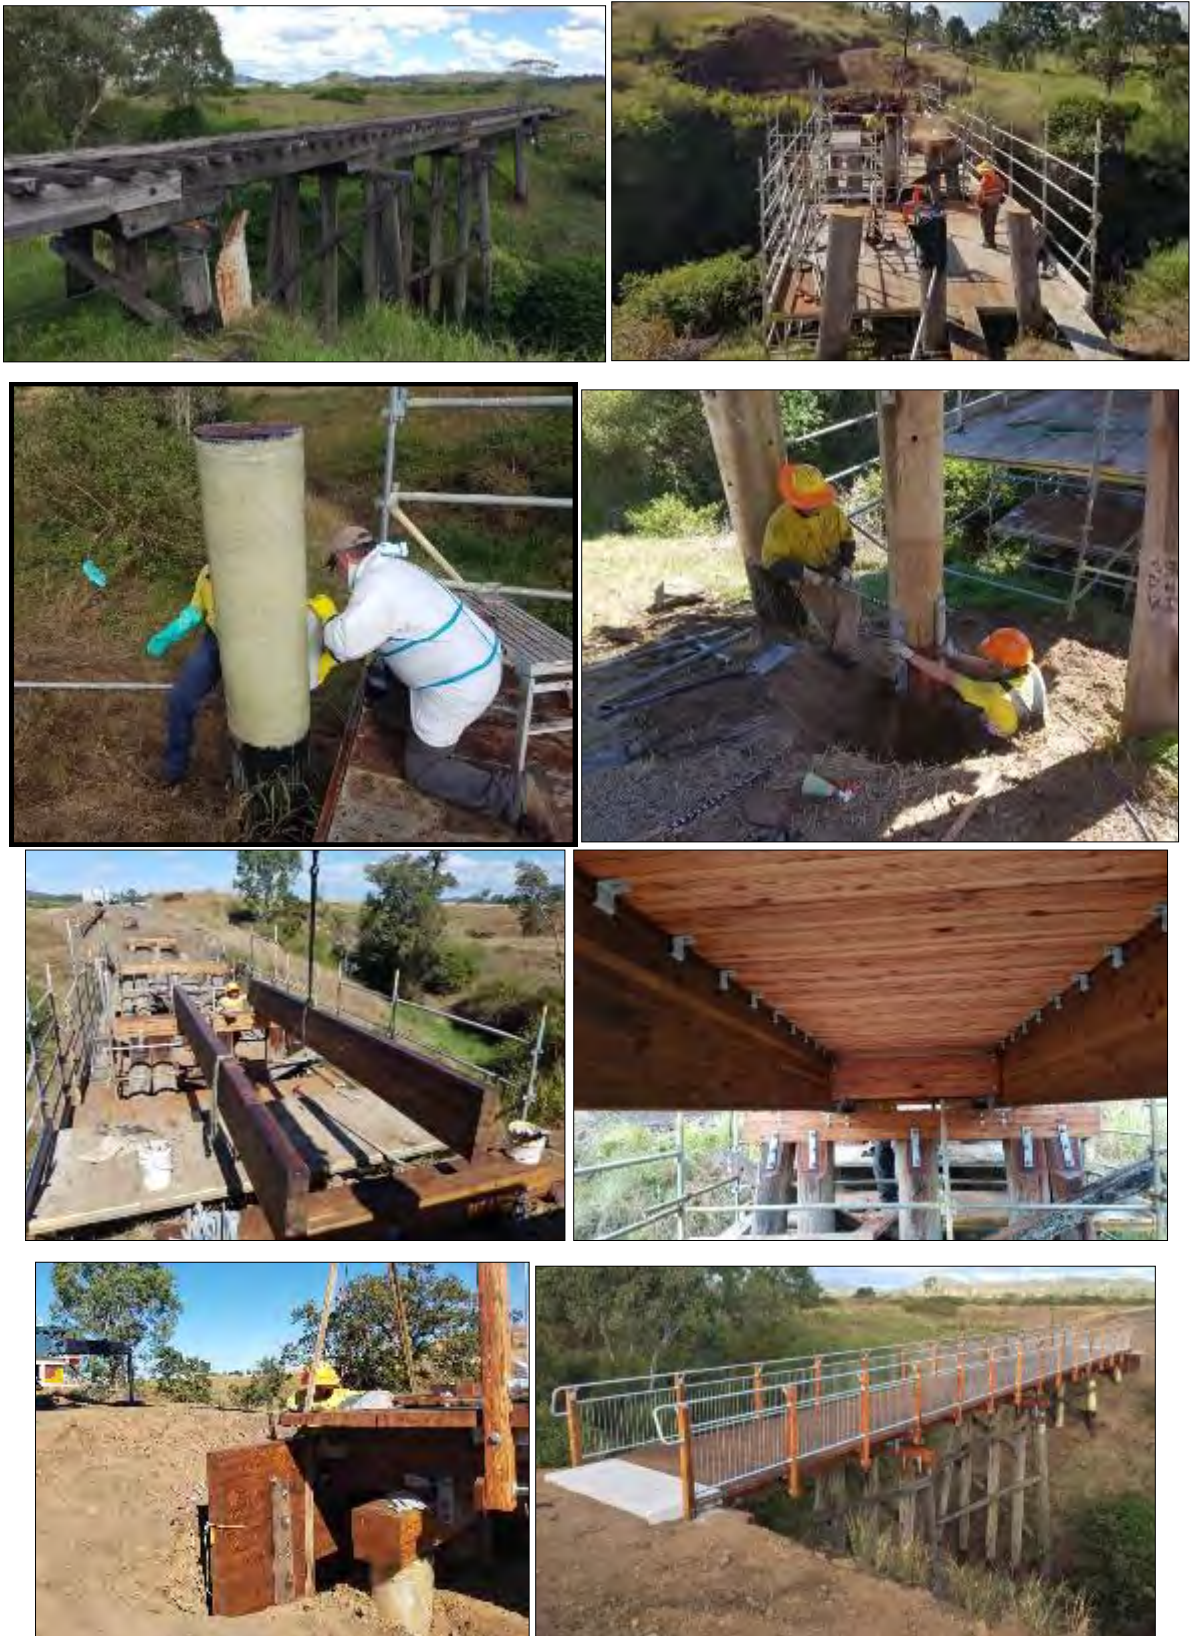
**Figure 11-4: The photo series above demonstrates Option 2 type of fix that was done for Jimmy Gully Bridge along the BVRT. The existing poor condition superstructure was removed and the piles were repaired with high strength fibre or posted with new section. New glulam back wall, caps, girders and deck system was installed utilising a horizontal connection detail.**

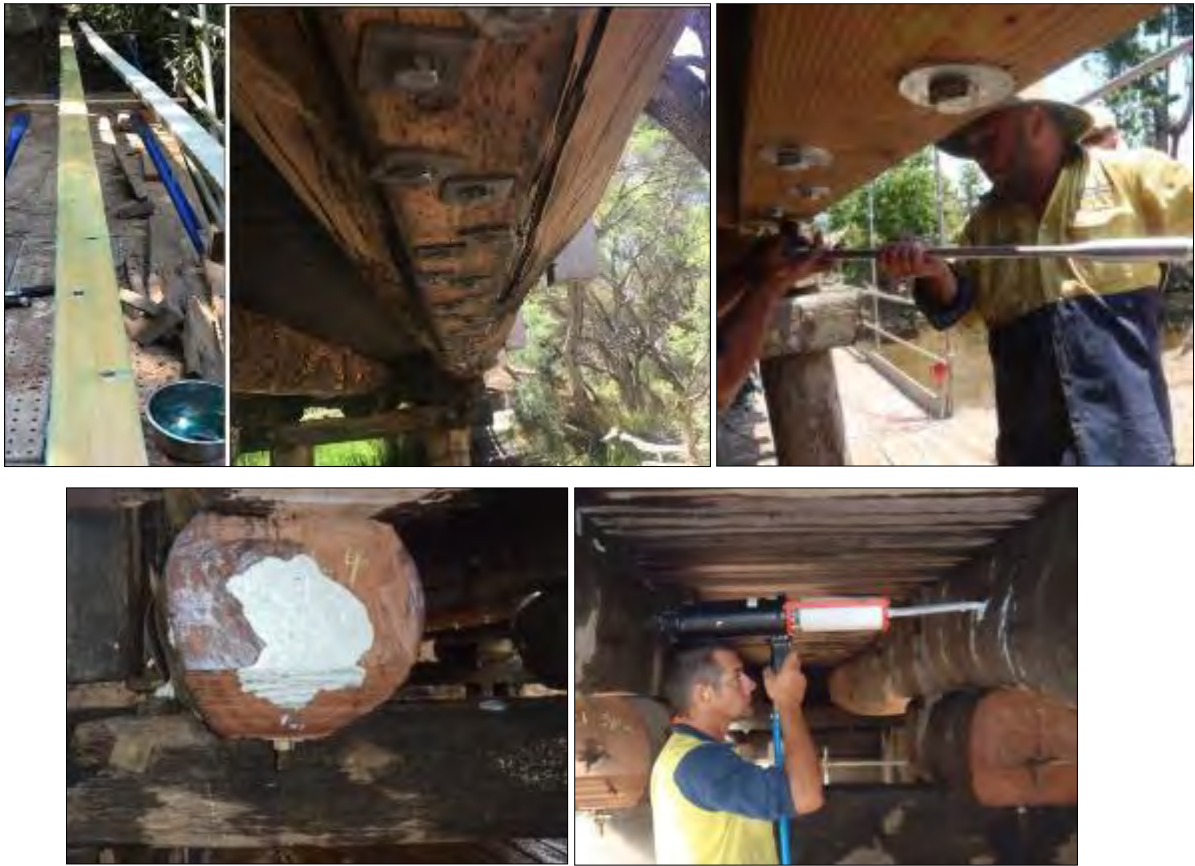
**Figure 11-5: The repair of Meachams Bridge in Cassowary Coast. The bridge was retrofitted with fibre reinforcement on the bottom of the girders, some corbels and girders were injected with a high strength epoxy. Some piles were also wrapped with high strength fibre and injected with epoxy, then the entire bridge was diffused with borate salt rods to neutralize decay growth.**

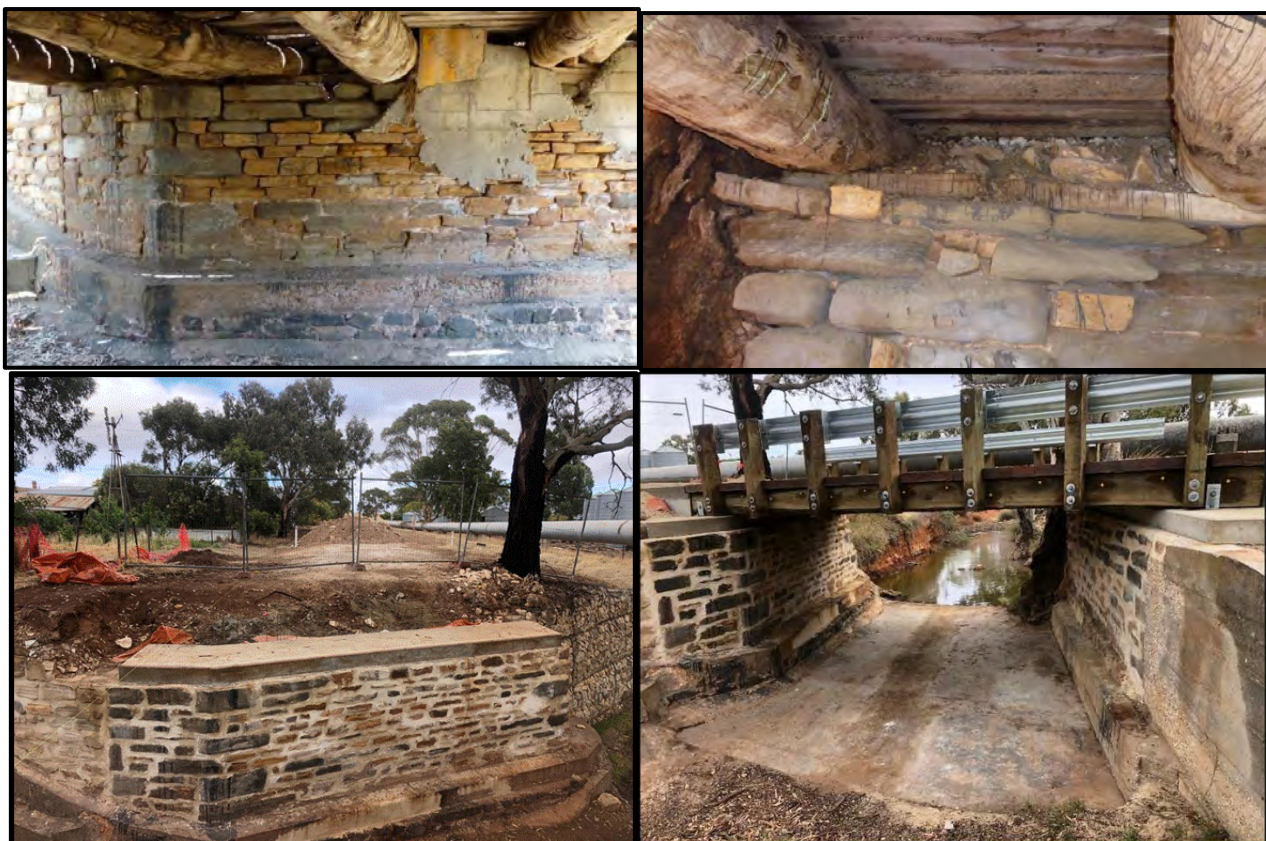
**Figure 11-6: The brick abutments and the hardwood deck and girders at Shannon Road Bridge were in very poor condition with major refurbishments required. The abutment wall was repaired where the mortar was missing due to weathering and scour. The abutment wall was levelled off in preparation for a loadbearing sill pad for the girders. Once the abutments were repaired a new hardwood girder and deck system was lifted into position and the bridge now has a load rating of 15 Tonne.**

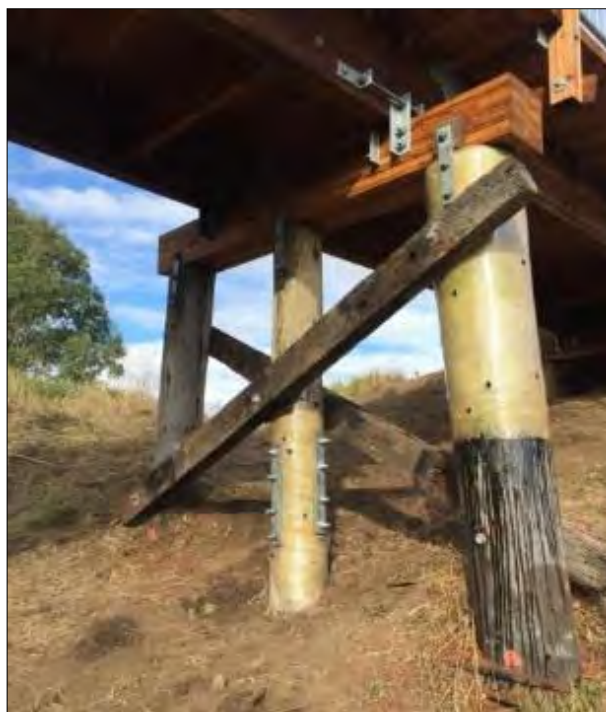
**Figure 11-9:** Diffuser (Borate Salt) rods are installed in the remaining hardwood elements in order to resist further deterioration of the timber caused by fungi growth. Note the red bungs are the decay ‘hotspots’ where the timber is prone to have a higher moisture content. These holes are required to be checked for rod depletion as per the issued maintenance manual (typically every 2-5 years depending on environmental conditions).

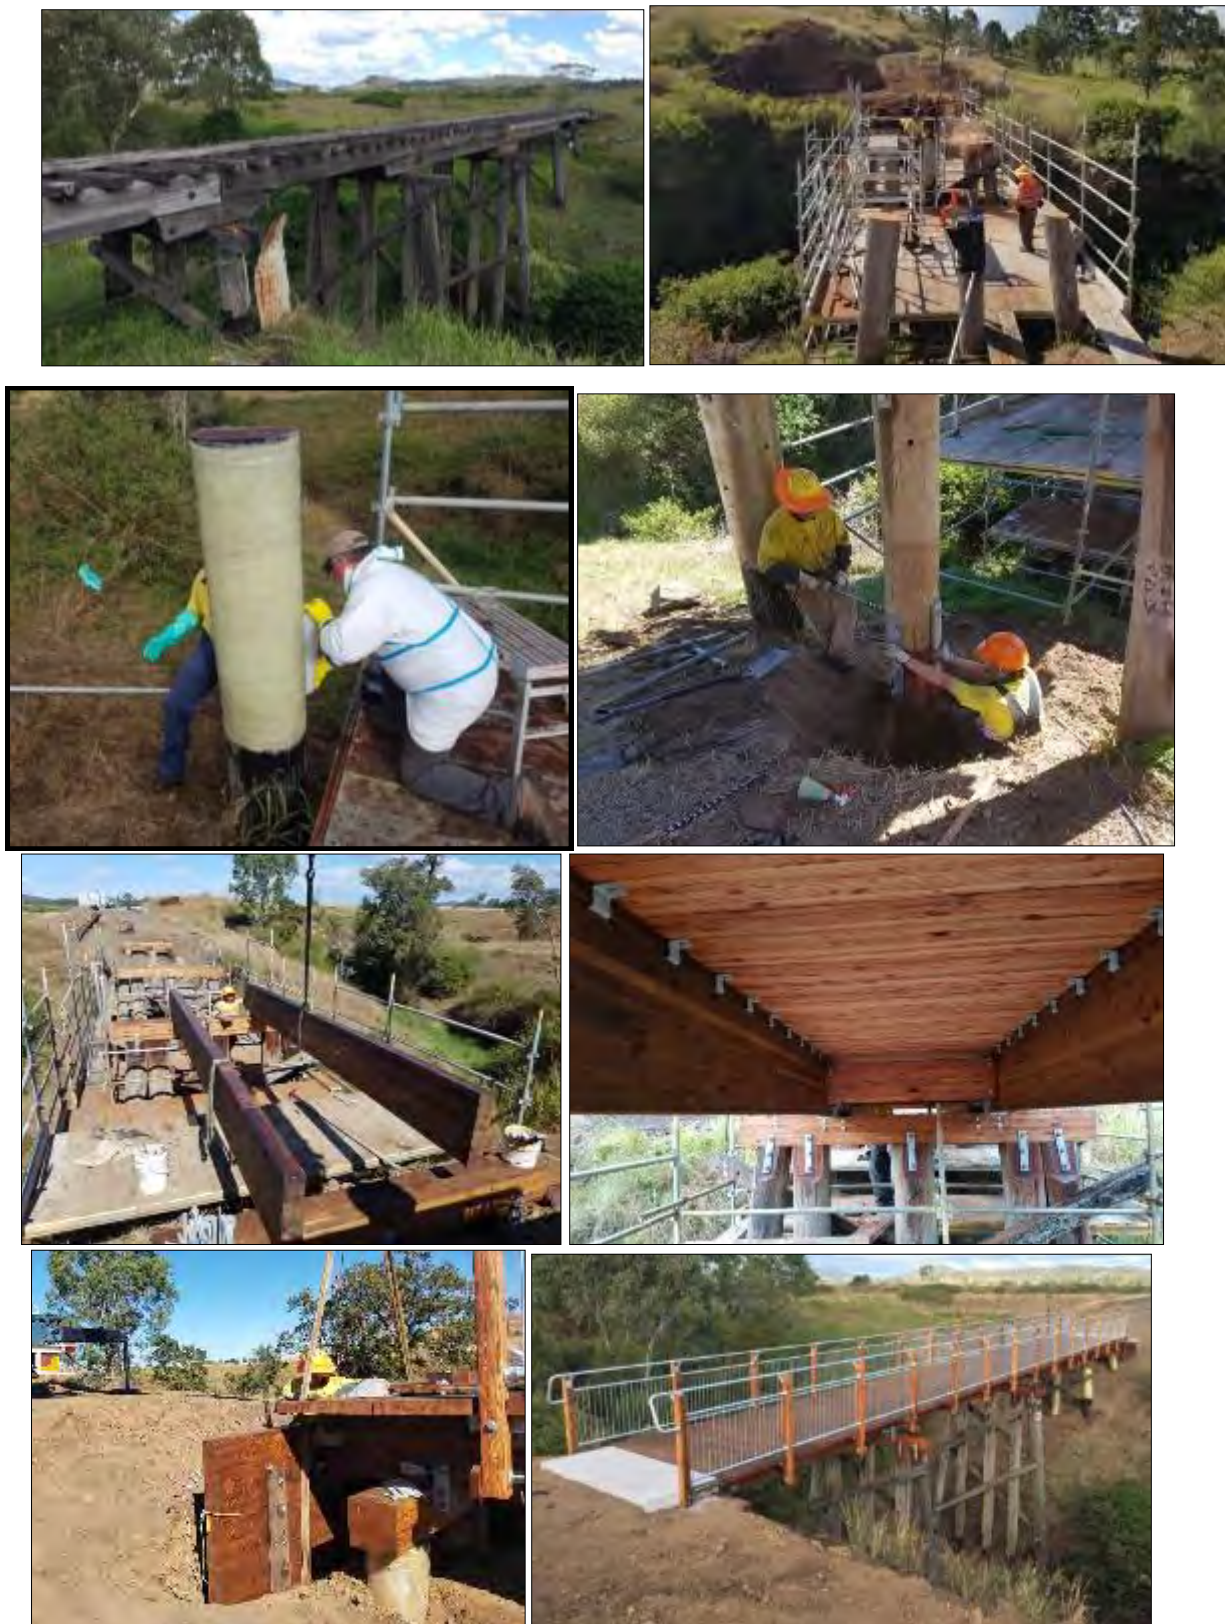
**Figure 11-10: The photo series above demonstrates an Option 2 type of fix that was done for Jimmy Gully Bridge along the BVRT. The existing poor condition superstructure was removed and the piles were repaired or posted with new section. New glulam back wall, caps, girders and deck system was installed utilising a horizontal connection detail.**
