Roofing and Guttering

The following fact sheet provides guidance on roofing and guttering for a property which is listed as a heritage item.

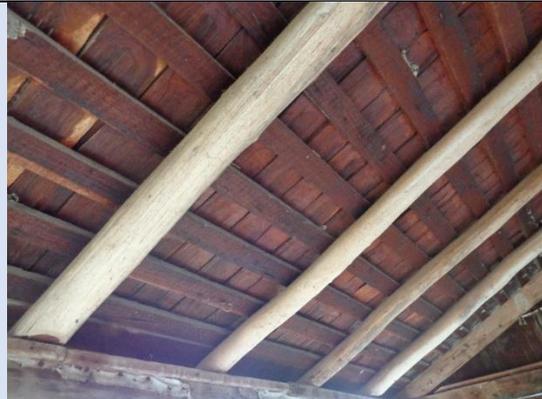
Timber shingles on a mid-19th century verandah.

Prior to the introduction of corrugated iron, many roofs of early buildings were covered with bark or timber shingles. Occasionally there are examples of these still in place under a corrugated roof. If you discover this, under a metal roof, it is important evidence of the history of the property and must be retained and carefully conserved.

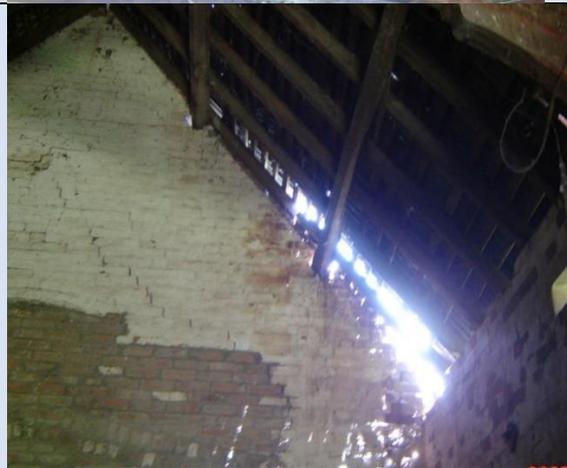
Close batten spacing is also another indicator of a former shingle roof.

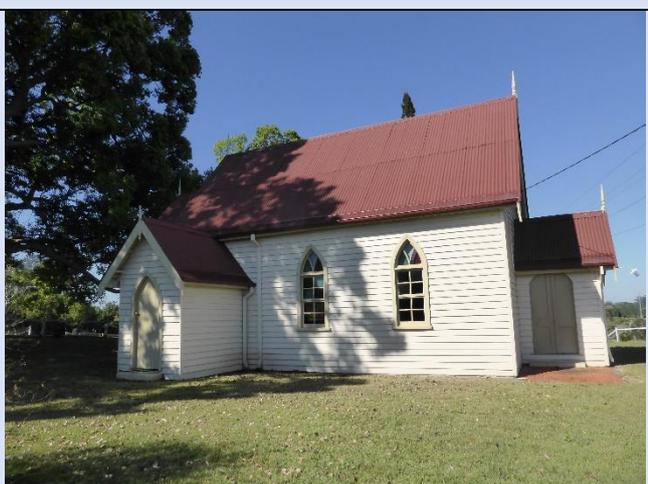
Short sheet galvanised roofing.

The horizontal line is a feature of the roof and retains its traditional visual character.

- If re-roofing is required, Galvanised Steel Z600 is the closest and aesthetically matching replacement product available.
- Original roofs were generally made in short sheets due to limitations with machinery and made to a size that could be handled by one person and were able to be transported by horse and cart. If you have a short sheet roof, the roof should ideally be retained or replaced in this way to retain the historic character of the building, at least on roof elevations which are visible to the street. Traditional roofing screws rather than modern hexagonal screws are also recommended.

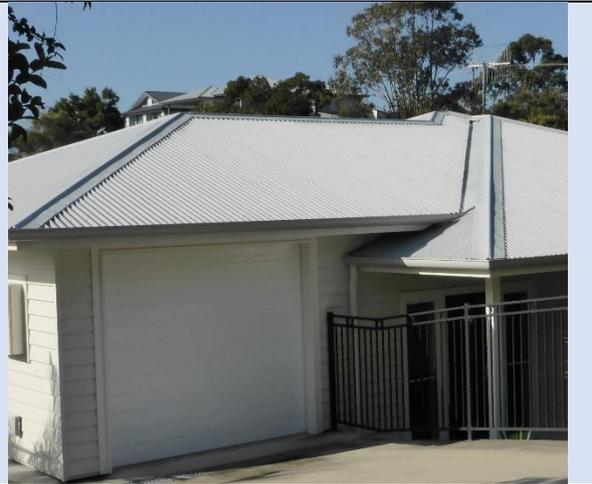
Modern Infill development with a light grey colorbond roof.

Colour bonded steel was introduced to Australia in 1966 and is pre-painted with an oven baked paint system available in a wide variety of colours. It is not the preferred finish for a heritage item or historic property as it lacks the traditional appearance of the spangles in the metal and has a homogenous painted appearance. However, pale to mid greys may be used for new infill development and will harmonise with the overall pattern of uncoloured metal in the Conservation Areas.

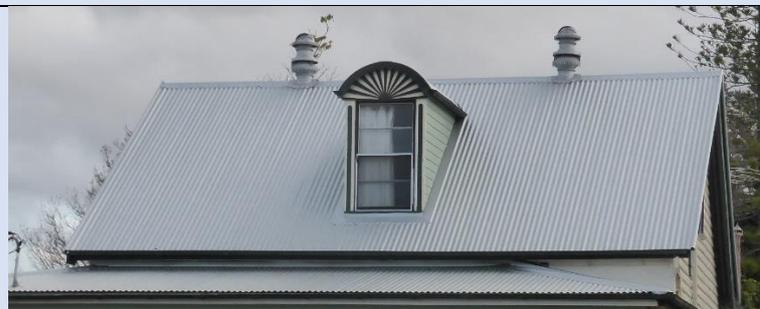
Zincalume roof

Introduced to Australia in 1976, Zincalume is a zinc/aluminium alloy with an uncoloured metal finish. The metal sheets are thinner but more resistant to corrosion, however it cannot be mixed with galvanised steel due to electrochemical corrosion. Although galvanised steel is the preferred material for a historic property, zincalume is an alternative roofing product which will harmonise with the general uncoloured traditional roofing. It tends to be more reflective initially and has a smaller spangle but over time will dull off and is suitable for the infill and less significant historic building stock.

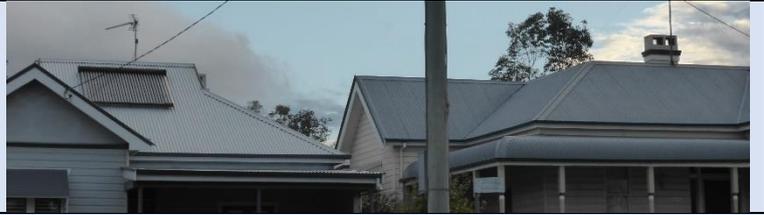
Zincalume roof on left hand side compared to galvanised roof on right hand side.

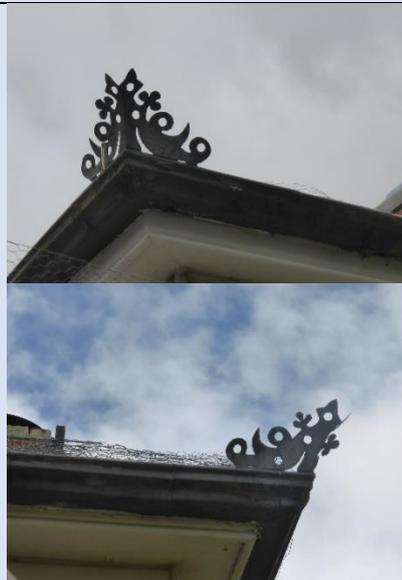
Ogee profiled gutter with acroterions to corner.

Buildings up to the late 1800s/early 1900s generally had 'Half Round' or 'Ogee' gutter profiles. Getting the details right is important in retaining the character of the building.

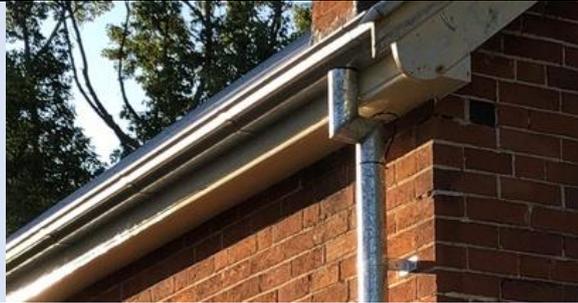
Ogee galvanised gutters and round downpipes

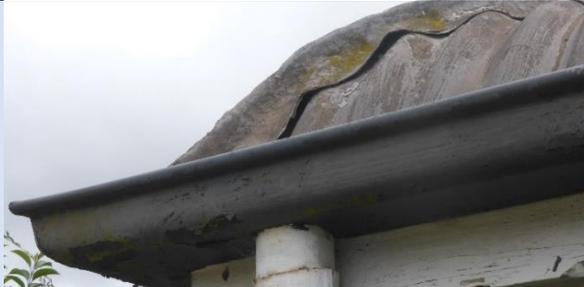
Low front quadrant profiled guttering

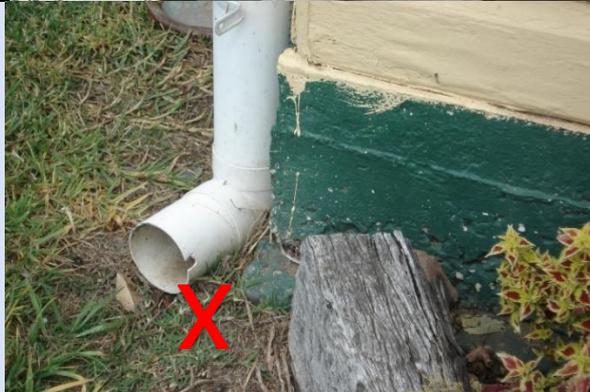
Stormwater should be piped or channelled away from the base of the building. Pooling of water at the base of the building can cause moisture in the foundations, rising damp in brickwork, attracts termites and can create more moisture in one part of the foundation than others leading to movement and cracking.
